**Critical Areas Reconnaissance
and
Hydrologic Assessment
for the
Central Kitsap School District
Central Kitsap Middle and High School
Silverdale, Washington**

Ecological Land Services, Inc.
1157 3rd Avenue, Suite 220
Longview, Washington 98632
(360) 578-1371
Project Number: 2399.02

October 26, 2016

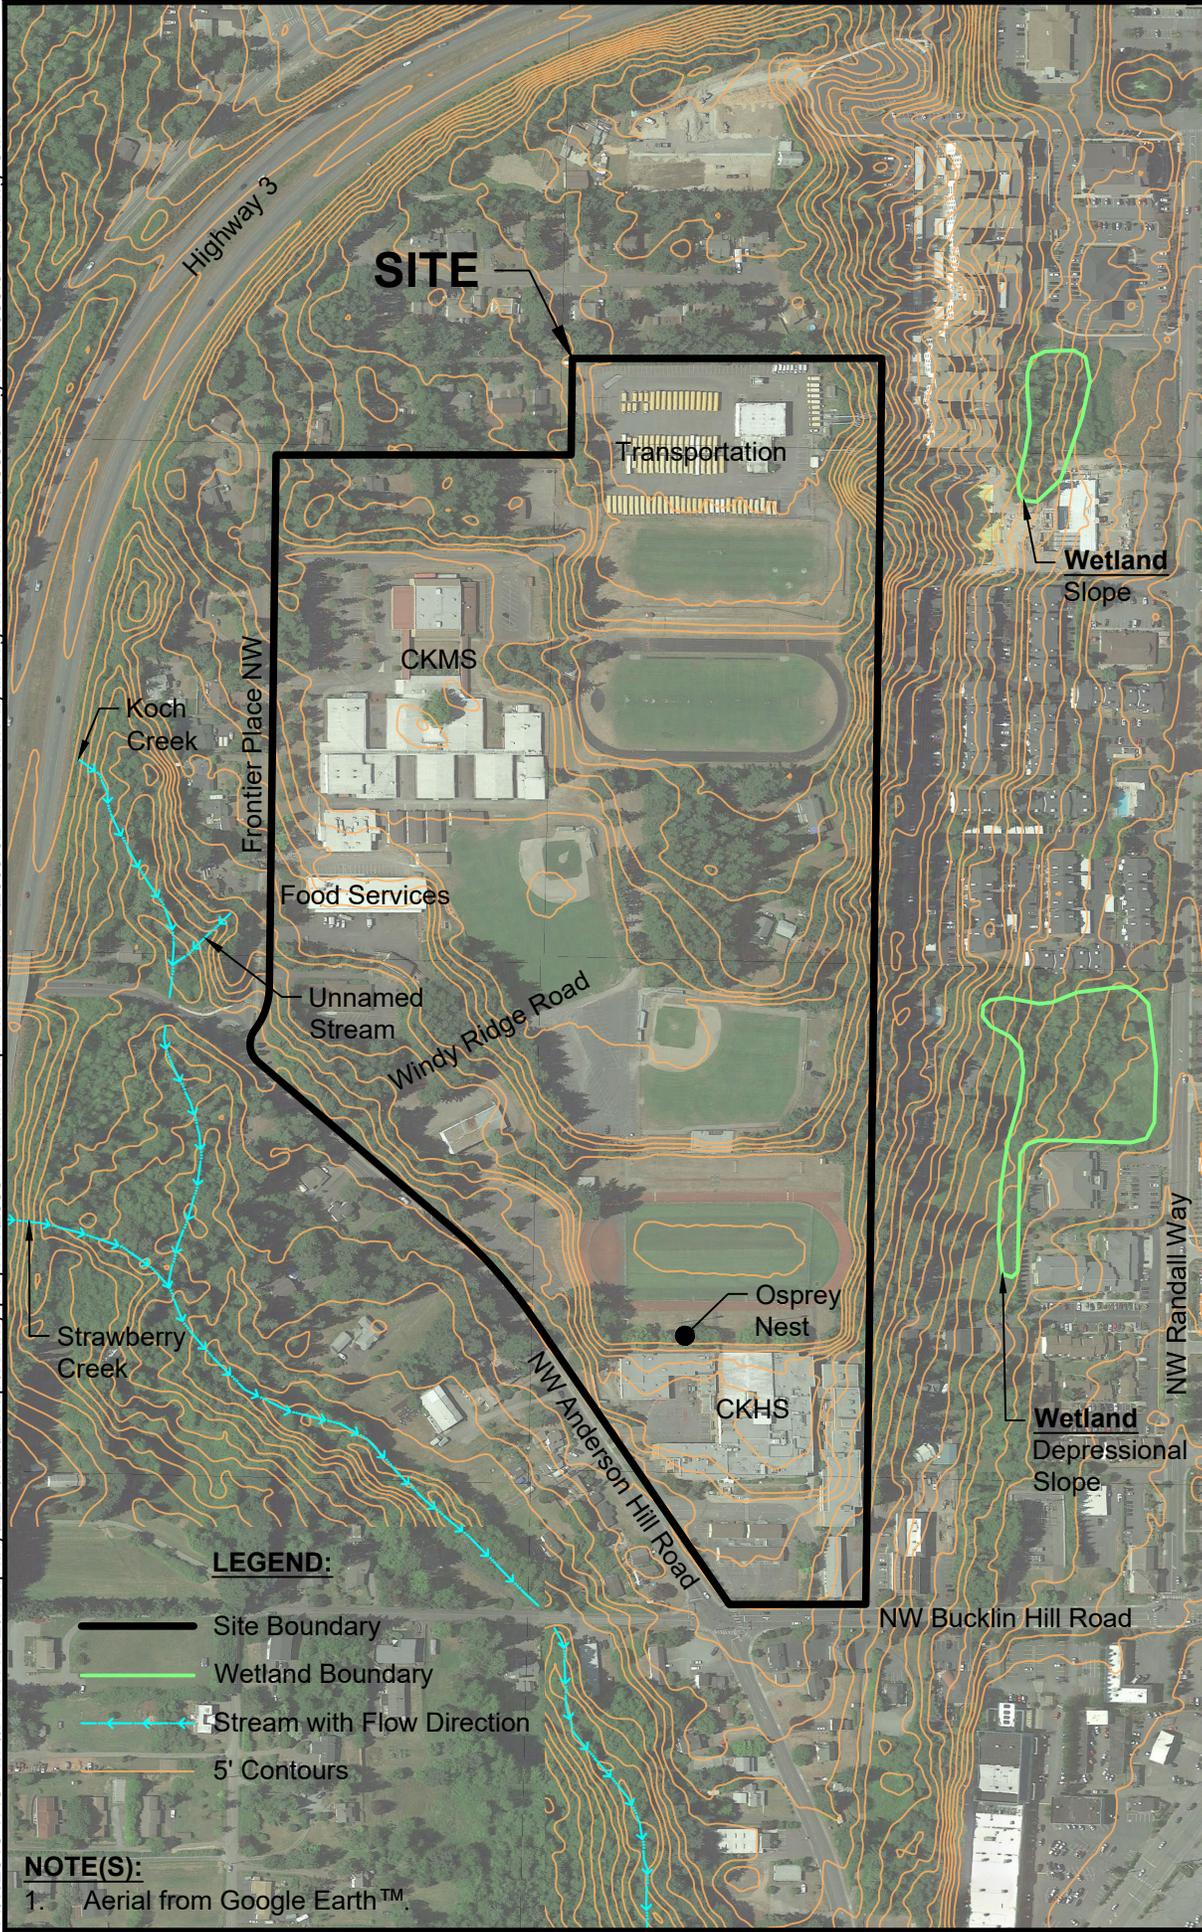
Figure 2
 SITE MAP
 CKHS CKMS Hydrologic Assessment
 Central Kitsap School District
 Kitsap County, WA
 Section 17, Township 25N, Range 1E, W.M.

to the west and down to Randall Way on the east. CKHS is located at the south end of the property with CKMS toward the north end and the transportation facility at the northeast corner. The athletic facilities, which include practice football and baseball fields, are located between the middle and high schools. The food service buildings are located in the middle of the property and are accessed from Frontier Place. Residential development borders all sides of the CKSD property with commercial property located east along Randall Way and south along Bucklin Hill Road. Most of the CKSD property is developed with areas of forest remaining on the slopes down to the east. Remnant forested areas are located at the entrance to the athletic fields from Anderson Hill Road at Windy Ridge Road and on the east side of the CKSD property (Figure 2).

CKSD property drains southerly into the Koch Creek basin, which joins with Strawberry Creek between Anderson Hill Road and Silverdale Loop Road (Figure 2).

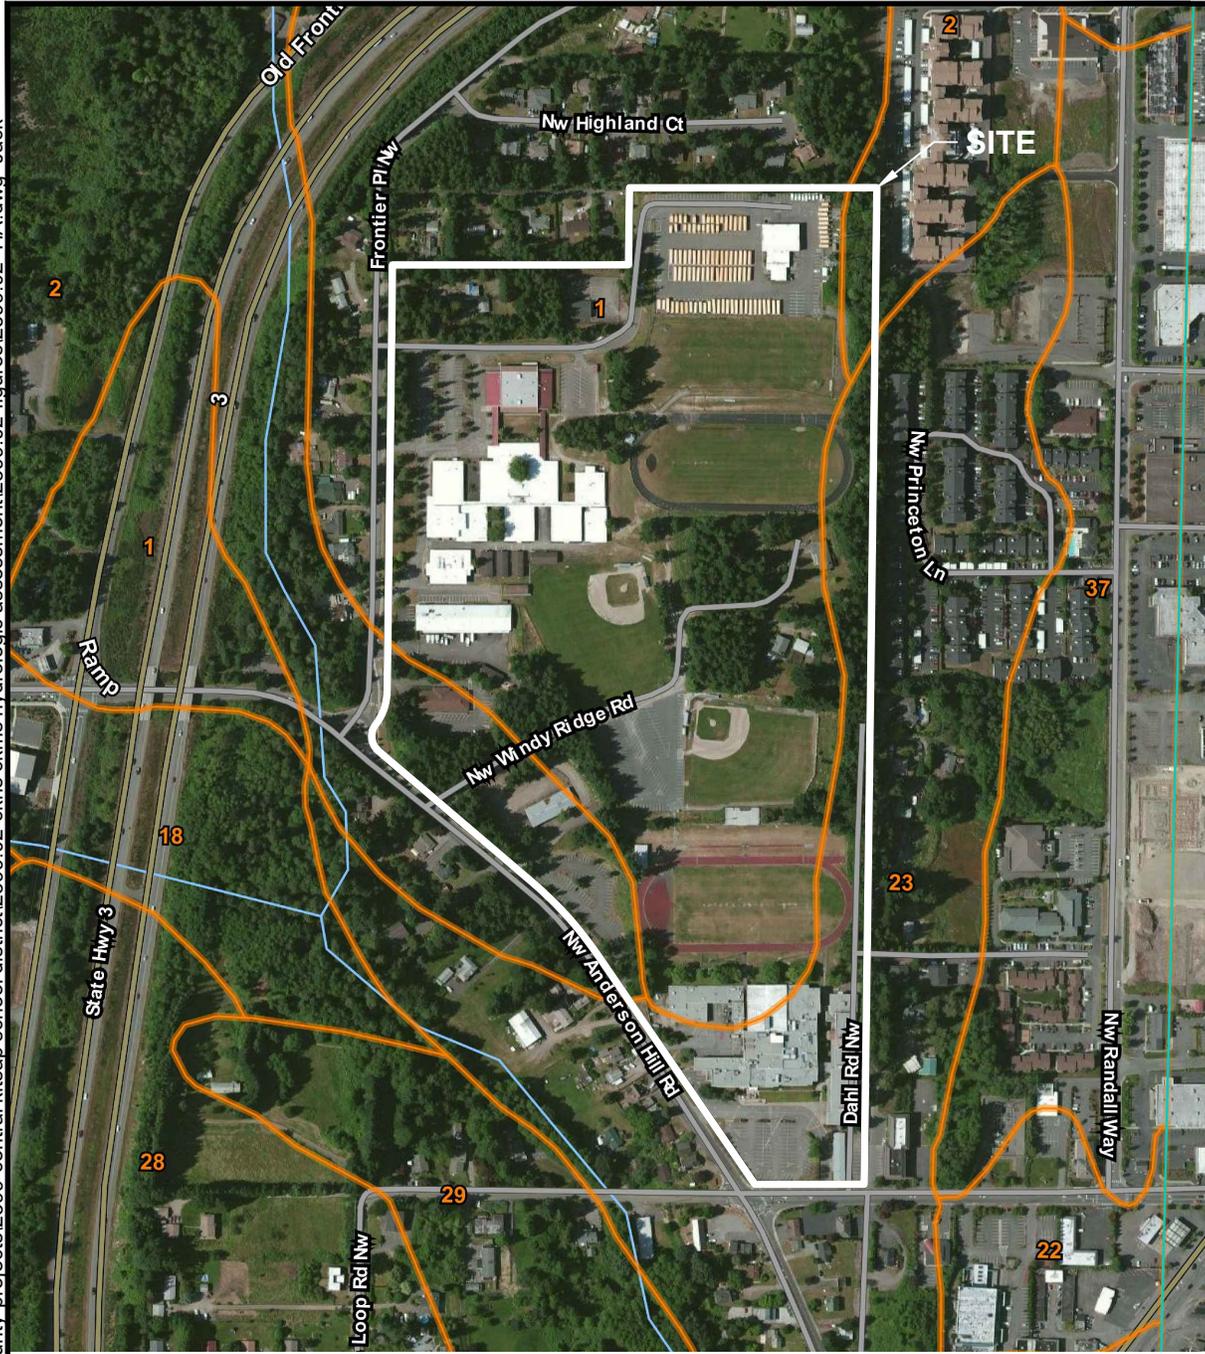
Figure 3
SOIL SURVEY MAP
 CKHS CKMS Hydrologic Assessment
 Central Kitsap School District
 Kitsap County, WA
 Section 17, Township 25N, Range 1E, W.M.

As referenced on the U.S.D.A. Natural Resources Conservation Service (NRCS 2015) website, the soils on the CKSD property is primarily Alderwood gravelly sandy loam, 0 to 8 percent slopes (1) with a smaller area of Kapowsin gravelly ashy loam, 6 to 15 percent slopes (23) at the south end (Figure 3). Offsite to the east, the soils are also mapped as Kapowsin (23) with an area of Norma fine sandy loam (37) mapped across Randall Way. The soils offsite to the west are mapped as Alderwood gravelly sandy loam, 8 to 15 percent slopes (2) and Kapowsin (23). The soils mapped on the CKSD property and the offsite areas immediately adjacent to the property are not classified as hydric and have no inclusions of hydric soil types (NRCS 2015). Norma fine sandy loam is classified as hydric but in the mapped area, wetlands do not currently exist due to commercial development along Randall Way. Areas mapped as hydric soils do not necessarily mean that an area is or is not a wetland—hydrology, hydrophytic vegetation, and hydric soils must all be present to classify an area as a wetland.

- 1 Alderwood gravelly sandy loam, 0 to 8 percent slopes. Not hydric.
- 2 Alderwood gravelly sandy loam, 8 to 15 percent slopes. Not hydric.
- 23 Kapowsin gravelly ashy loam, 6 to 15 percent slopes. Not hydric.

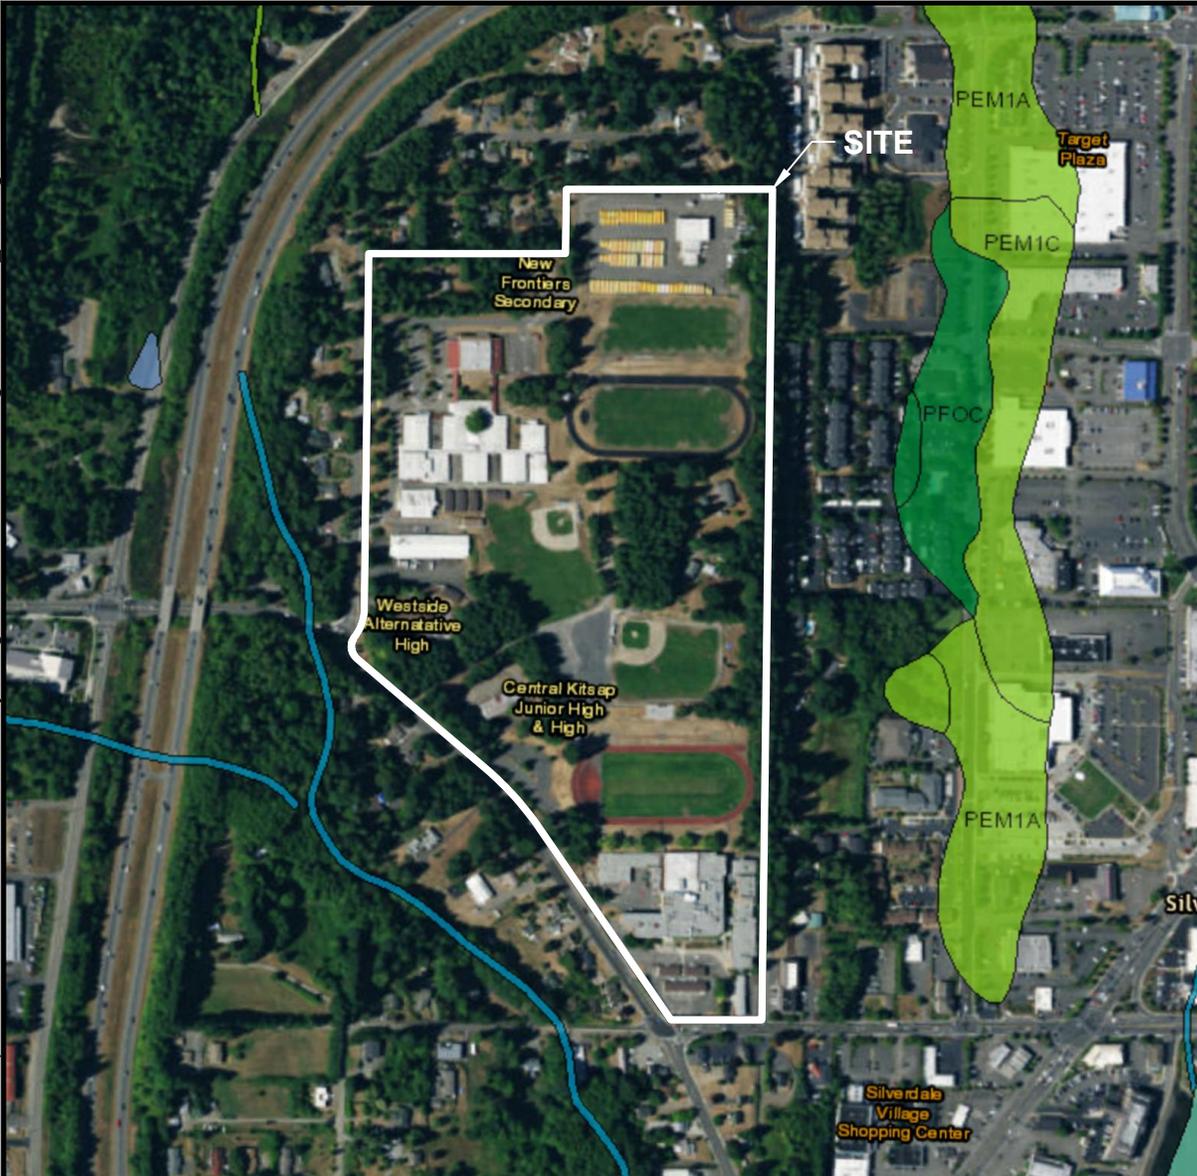
Figure 4
NATIONAL WETLANDS INVENTORY MAP
CKHS CKMS Hydrologic Assessment
Central Kitsap School District
Kitsap County, WA
Section 17, Township 25N, Range 1E, W.M.

National Wetlands Inventory (NWI) maps no wetlands on the CKSD property but indicates a large wetland system offsite to the east and the stream system offsite to the west (Figure 4). The wetland mapping to the east represents historic wetlands that are no longer in existence due to the commercial development on the west side of Silverdale. The stream system mapped to the west is Koch Creek, which flows southerly into to Dyes Inlet after it joins with Strawberry Creek downstream of Anderson Hill Road. NWI maps should be used with discretion because they are used to gather general wetland information about a regional area and therefore are limited in accuracy for smaller areas because of their large scale.

No mapped wetlands indicated onsite by US Fish & Wildlife Service.

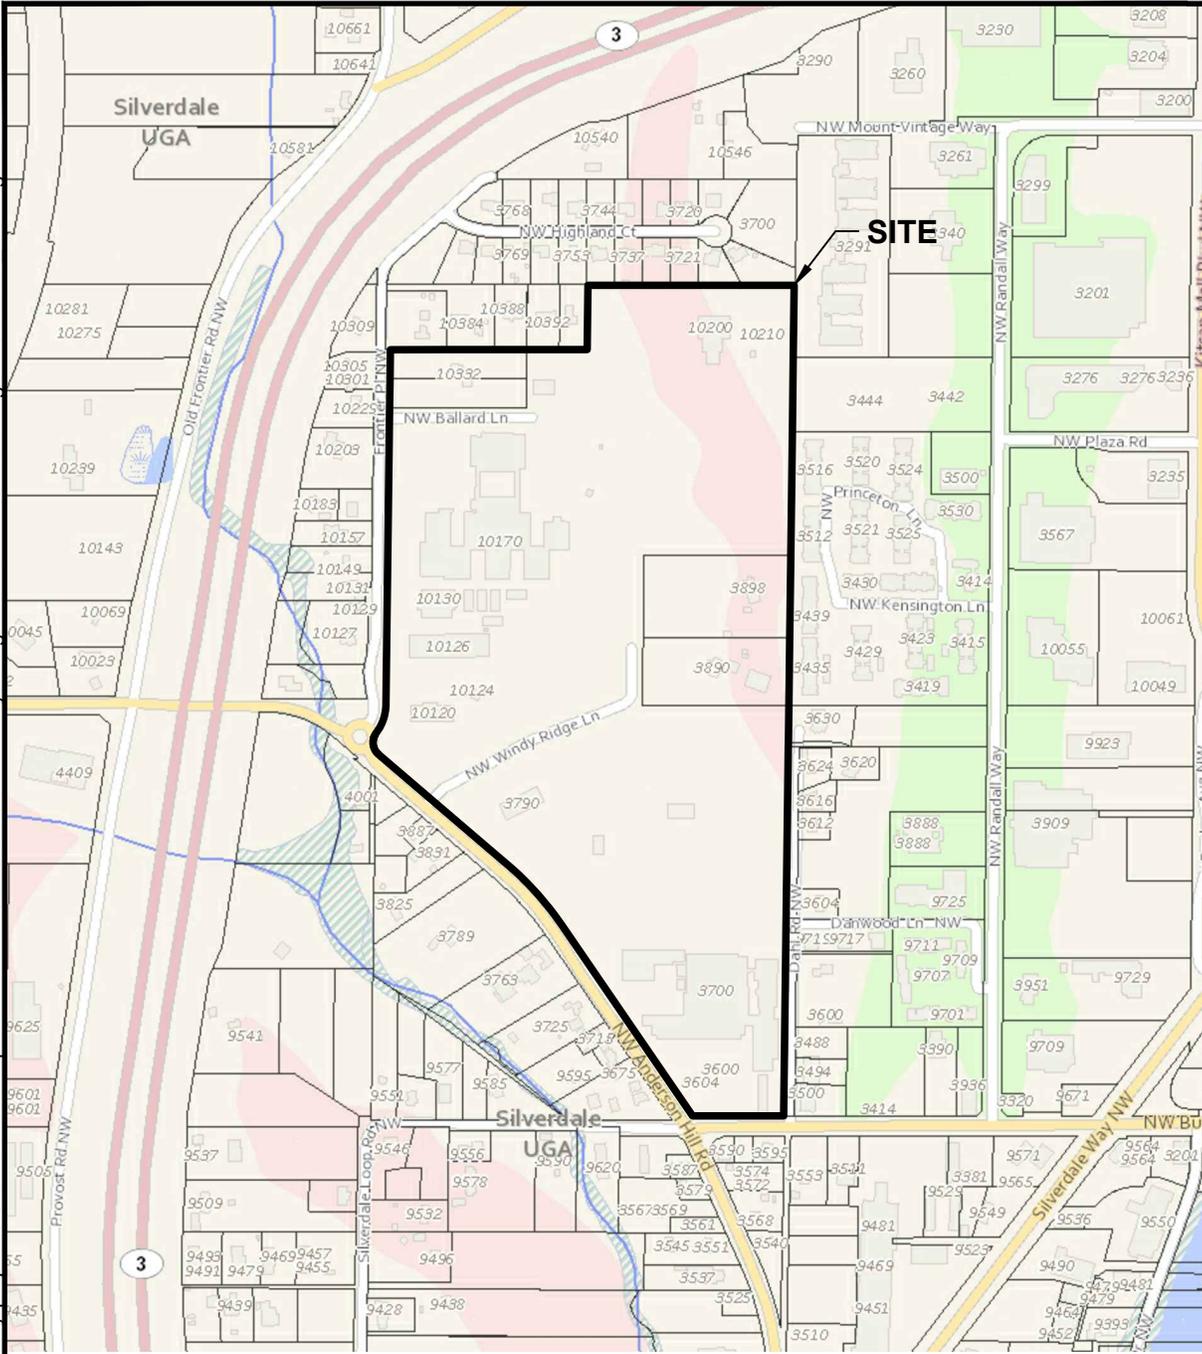
Figure 5
KITSAP COUNTY CRITICAL AREAS MAP
 CKHS CKMS Hydrologic Assessment
 Central Kitsap School District
 Kitsap County, WA
 Section 17, Township 25N, Range 1E, W.M.

The Kitsap County GIS mapping tool shows the areas of potential wetland as mapped by the NRCS and the NWI, which was laid over the county tax parcel maps (Figure 5). Therefore, potential wetlands are mapped to the east of the CKSD property along Randall Way in the same areas shown on the NRCS map and the NWI. Koch Creek is mapped as indicated on the NWI map but the floodplain of the stream is included on the county map. It does not show potential wetlands associated with the stream. Critical area maps should be used with discretion because they are used to gather general wetland information about a regional area and therefore are limited in accuracy for smaller areas because of their large scale.

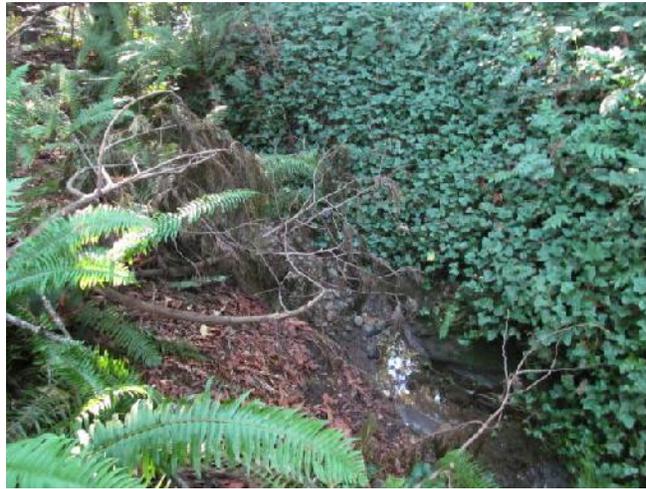
Critical areas to the west include Koch Creek, which flows southerly toward Anderson Hill Road west of Frontier Place (Photoplate 2). There is a small stream that begins along Frontier Lane across from the food services building. The small stream begins abruptly at the start of a shallow ravine and flows southerly into Koch Creek. Koch Creek then flows under Anderson Hill Road and joins with Strawberry Creek several hundred feet south of the culvert (Photoplate 2). The site reconnaissance revealed that there are no wetlands present along Koch Creek on either side of Anderson Hill Road. The stream channel is at least 5 feet wide and at the time of the reconnaissance, there was rapid flow due to heavy rain events the preceding days (Photoplate 2). The forest on either side of Koch Creek is dense with a low shrub and herbaceous understory.

Photo 1 was taken of the short stream that begins just west of the CKSD administrative building along Frontier Place. This stream is confined to a steep sided, yet short ravine that ends a culvert under Anderson Hill Road.

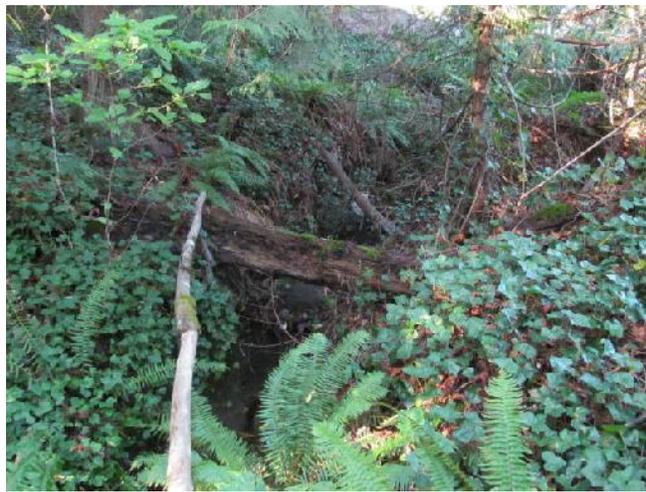
Photo 2 shows another view of the stream shown in Photo 1.

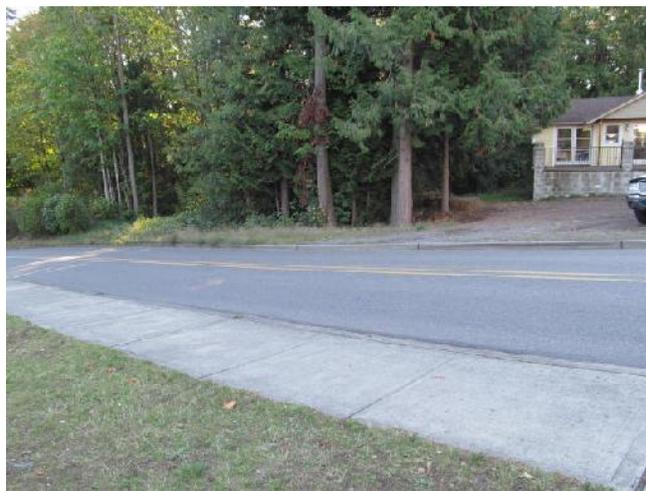
Koch Creek is separated from the CKSD property by Frontier Place and it appears that some runoff may enter the stream system via the storm sewer system along Anderson Hill Road, which is downslope of the CKSD property. Water from the CKSD property does not enter the short stream west of the food service building because of the curb along the west edge of Frontier Place. Water instead appears to leave the CKSD property and flow down Frontier Place to Anderson Hill Road during severe storm events. It is unclear how it enters the Koch Creek drainage downslope of Anderson Hill Road but it likely enters a storm sewer system. It appears that the north half of the

Photo 3 was taken from the CKSD property and looks southwesterly across Frontier Place toward the start of the short stream in Photos 1 and 2. The stream begins just downslope of the trees in the middle of the photo.

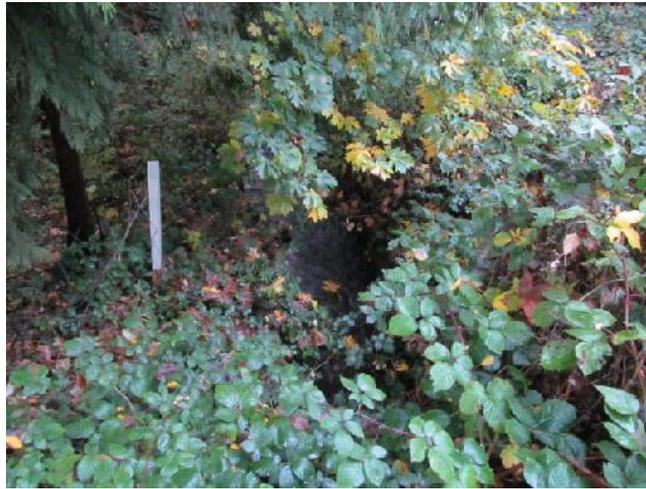
Photo 4 was taken from Anderson Hill Road and looks down into Koch Creek before it enters the culvert under the road. The slope down to the stream is dominated by blackberry thickets. There are upland areas on both sides of the creek. The small stream enters Koch Creek about 100 feet from this point.

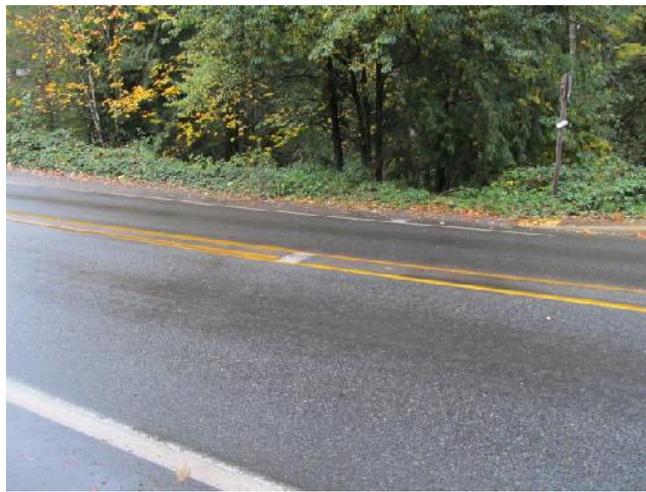
Photo 5 was taken from the south side of Anderson Hill Road and looks across the road at the culvert crossing.

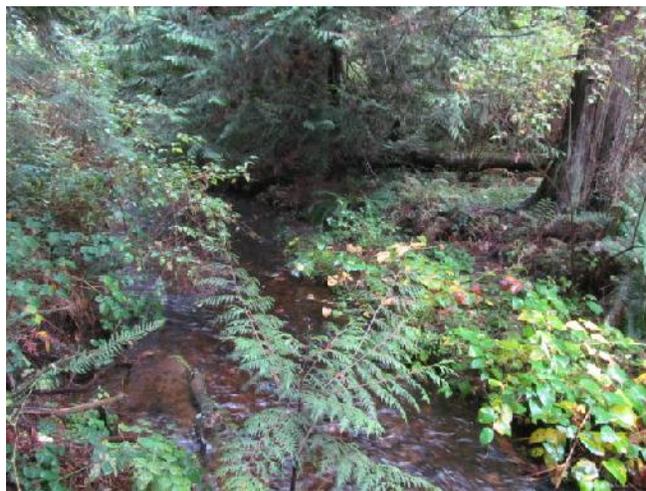
Photo 6 was taken from along Koch Creek downstream of Anderson Hill Road. There is level upland on both sides of the channel. Water flow in the channel was high and fast due to recent heavy rain events.

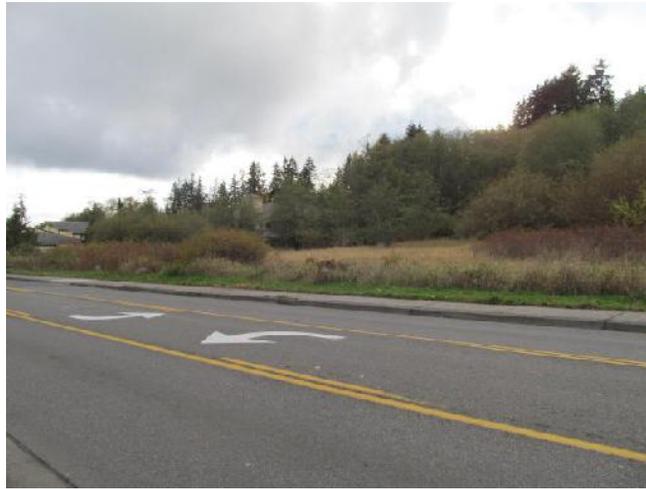
The wetland areas east of the CKSD property are on sloping terrain and primarily receive groundwater that discharges from the slope. The wetlands may also receive water from runoff generated on the adjacent developed properties but there does not appear to be any runoff directed into these wetlands from the CKSD property. It appears that perhaps some groundwater recharge is occurring on the CKSD property in the form of water from the fields and landscaping that eventually discharges into the wetland. The surface water runoff entering these wetlands appears to originate at the developed properties that are situated between the CKSD property and the wetlands. The wetlands downslope of the CKSD property have been determined to be Waters of the U.S. by the U.S. Army Corps of Engineers because they are connected to Dyes Inlet via culverts (Wiltermood 2005). This information was obtained by the project biologist during the permitting for wetland fill for the Vintage at Silverdale Apartments. The east side of the CKSD property drains easterly toward the wetlands on the adjacent properties.

Photo 7 was taken from along Randall Way across from the wetland that lies north of the First American Building. The wetland occupies the level grassy area in the middle of the photo (just beyond the road) with a sloping portion in the deciduous trees just beyond the level portion. The tall conifer trees in the upper right background are just downslope and east of the CKSD property.

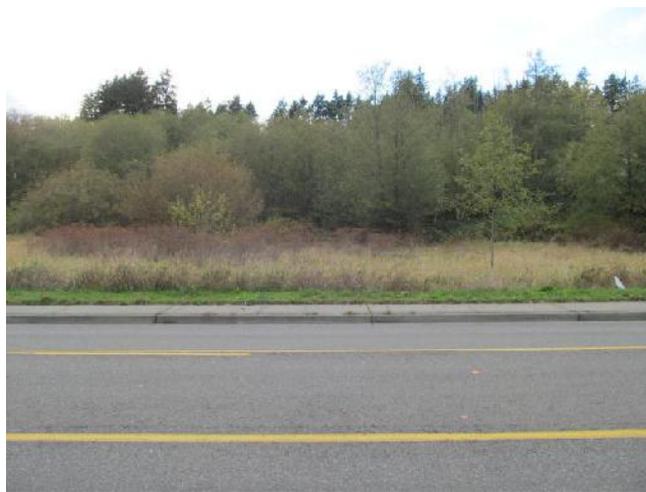
Photo 8 was taken from the same location as Photo 4 and looks west across Randall Way. As described in the Photo 4 discussion, the level grassy area is composed of depressional wetland with slope wetland conditions in the tree area. The conifer trees beyond the deciduous trees are growing on property adjacent to the CKSD property.

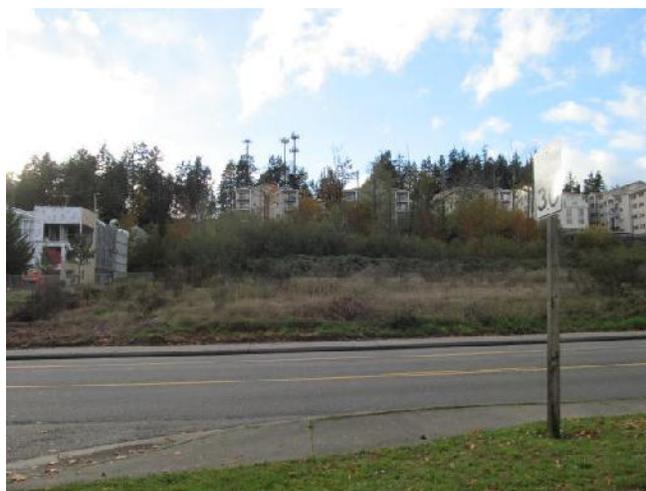
Photo 9 was taken from the southwest corner of the Target property, which is located across Randall Way from the Vintage at Silverdale Apartment complex. The apartments are located just this side of the cell towers and conifers trees in the background with the wetland just downslope of the apartments. The lower portion of this wetland was filled to accommodate future development.

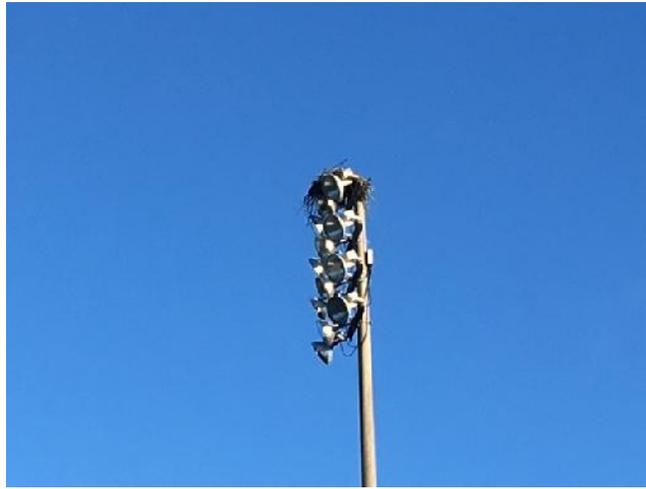
Photo 10 was taken from near the bottom of the light standard atop which the osprey nest has been constructed.

Osprey nests can be removed outside the nesting season after receiving a permit from the Washington Department of Fish and Wildlife (WDFW). Additional permits may be required from the U.S. Fish and Wildlife Service (USFWS) for nest removal during the nesting season but defers to the WDFW during the non-breeding season (Miller 2016). Replacement of the nest is not required and if voluntary replacement is proposed, a plan showing the nest and location must be submitted. Removal of the nest must be completed by an approved falconry or osprey expert (Murphie 2016). A permit has been issued by WDFW for removal of the osprey nest because it is the non-nesting season and the nest is an impediment to maintenance activities (Attachment 1).

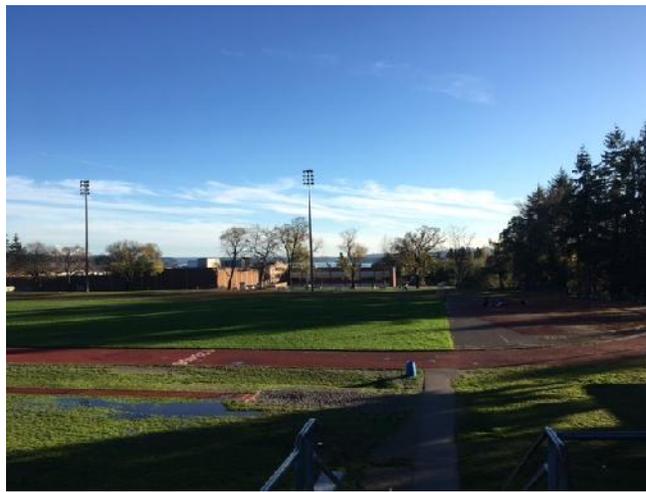
Photo 11 was taken from the parking lot above the track and field location and looks south toward the high school. The light standard on the right houses the osprey nest. The high school building is just beyond the lights.

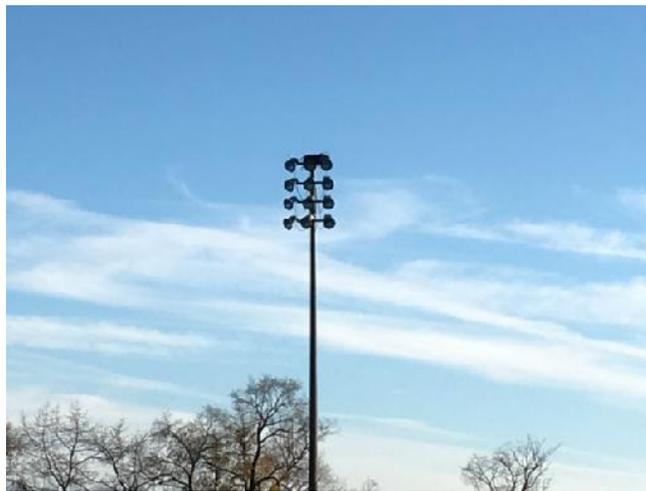
Photo 12 was taken from the same location as Photo 11. This photo was zoomed in order to show a close up view of the nest.
