GEOTECHNICAL SUPPLEMENT NO. 1: STORMWATER INFILTRATION

Central Kitsap High School and Middle School Redevelopment
10130 Frontier Place NW and 3700 NW Anderson Hill Road
Silverdale, Washington

March 10, 2017

Project No. 6-917-18096-0

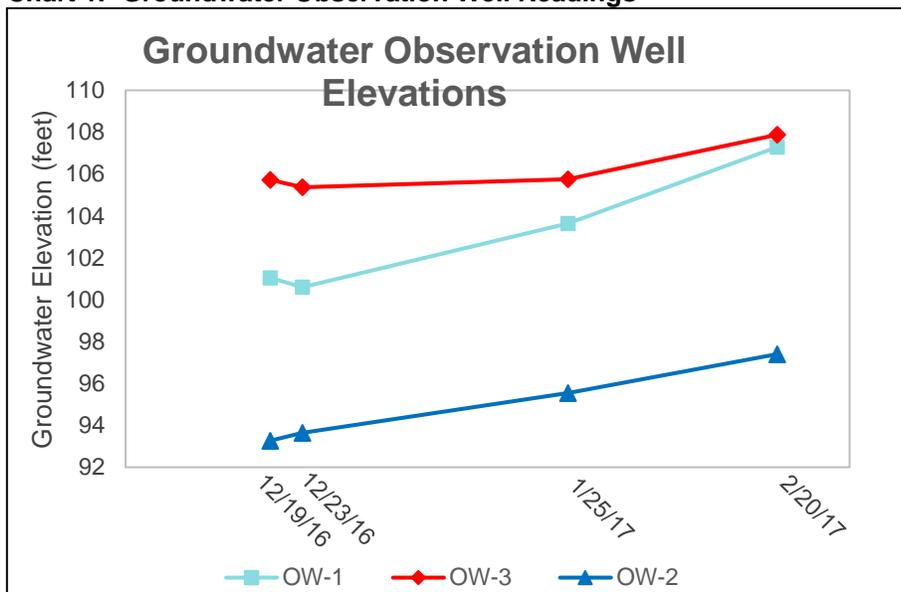
Chart 1. Groundwater Observation Well Readings

The groundwater data collected indicates 3 feet or more feet of vertical separation between the infiltration pond design base elevations and groundwater. The highest groundwater elevation readings and inferred groundwater gradient are displayed on Figure 3. Chart 1 summarizes our collected water level readings.

- Boring OW-3, at the north infiltration pond, encountered groundwater at 30 feet bgs (elevation 97).
- Boring OW-1, at the central infiltration pond, encountered groundwater 25 feet bgs (elevation 96).
- Boring OW-2, at the south infiltration pond, did not encounter groundwater at the time of drilling.

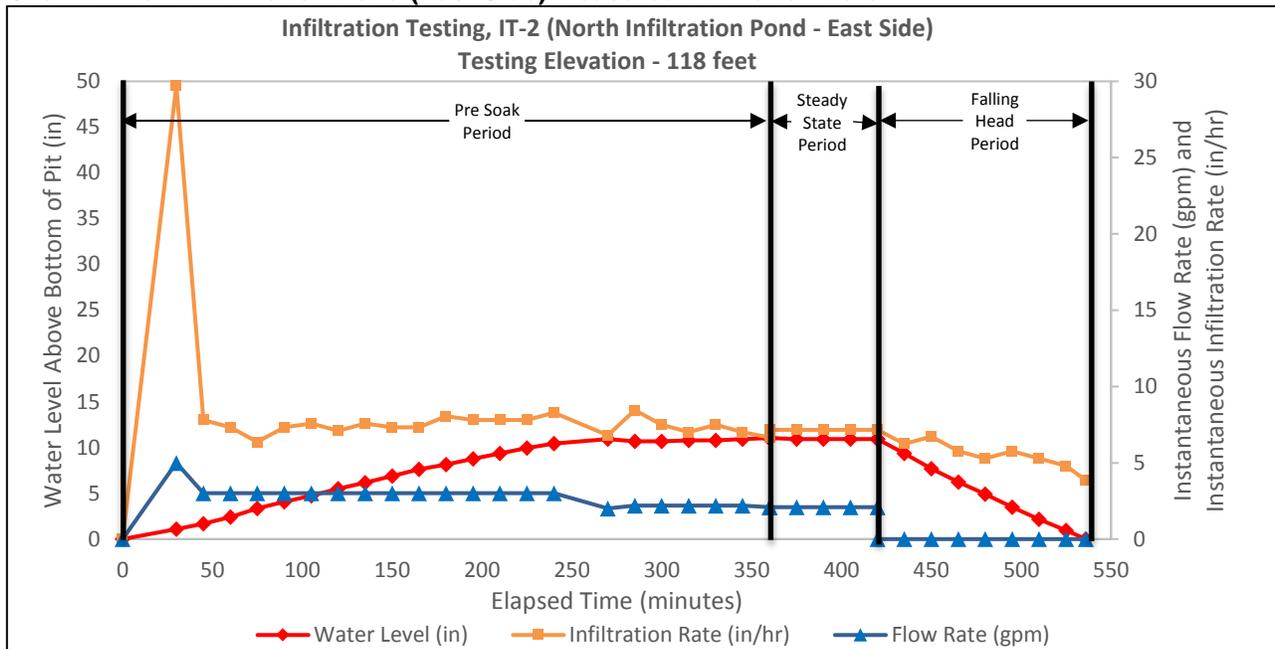
Chart 2 North Infiltration Pond (East Side) Measured Infiltration Rate

The constant-head (steady-state period) measured infiltration rates in the north infiltration pond were 7.1 inches/hour (IT-2) and 9.2 inches/hour (IT-3), for an average rate of 8.1 inches/hour. Using an intermediate correction factor for site variability, due to silt lenses, the design infiltration rate for the north infiltration pond was 0.8 inch per hour, after applying correction factors shown in Table 3.

After compiling and analyzing the collected field data, the infiltration rates for each pond location were calculated. Plots of the measured infiltration rates over the duration of testing for the four PIT are presented in Charts 2 through 5.

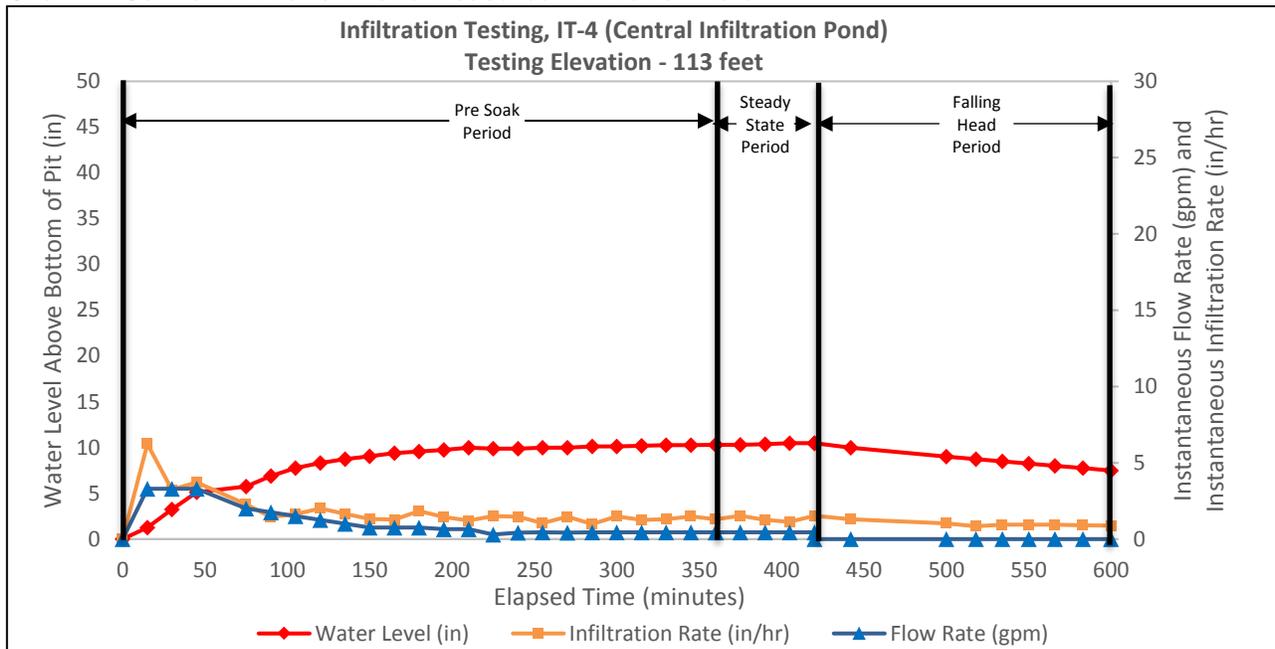
Chart 4 Central Infiltration Pond Measured Infiltration Rate

Using the constant-head (steady-state period) measured infiltration rate (1.3 inches per hour) and an intermediate correction factor for site variability, due to silt lenses, the design infiltration rate for the central infiltration pond was found to be 0.16 inch per hour, after applying correction factors shown in Table 3.

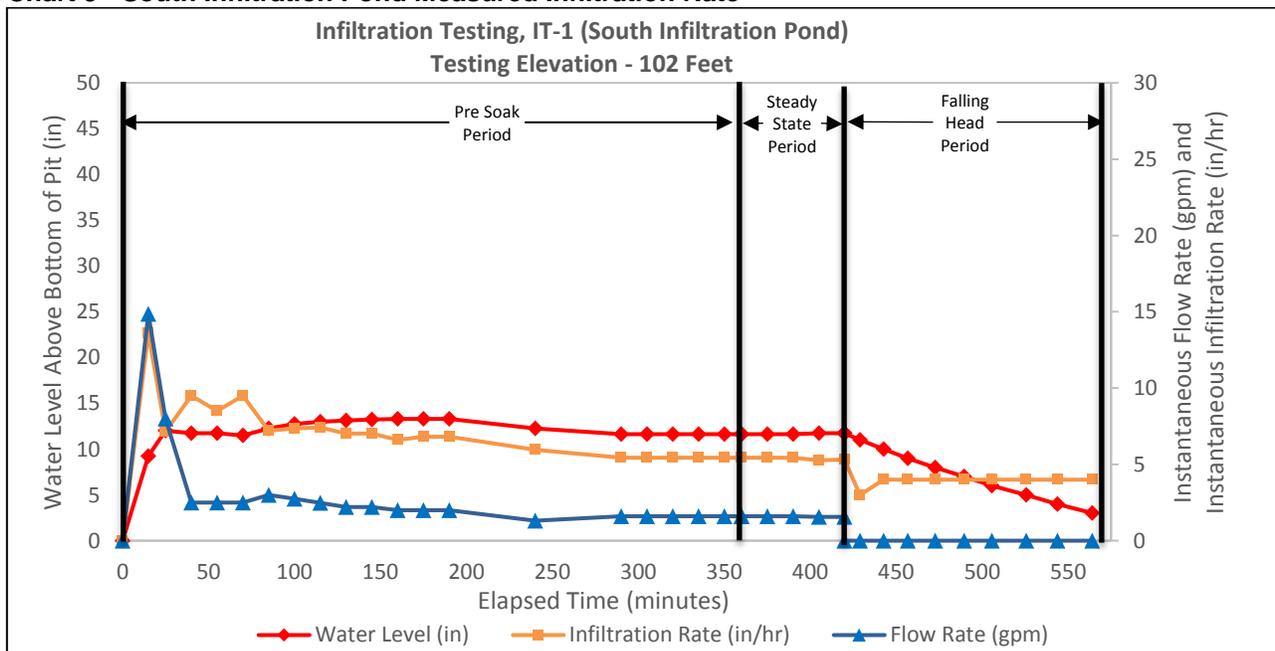
Chart 5 South Infiltration Pond Measured Infiltration Rate

Using the constant-head (steady-state period) measured infiltration rate (5.4 inches per hour), the design infiltration rate for the south infiltration pond was found to be 0.8 inch per hour, after applying correction factors shown in Table 3.

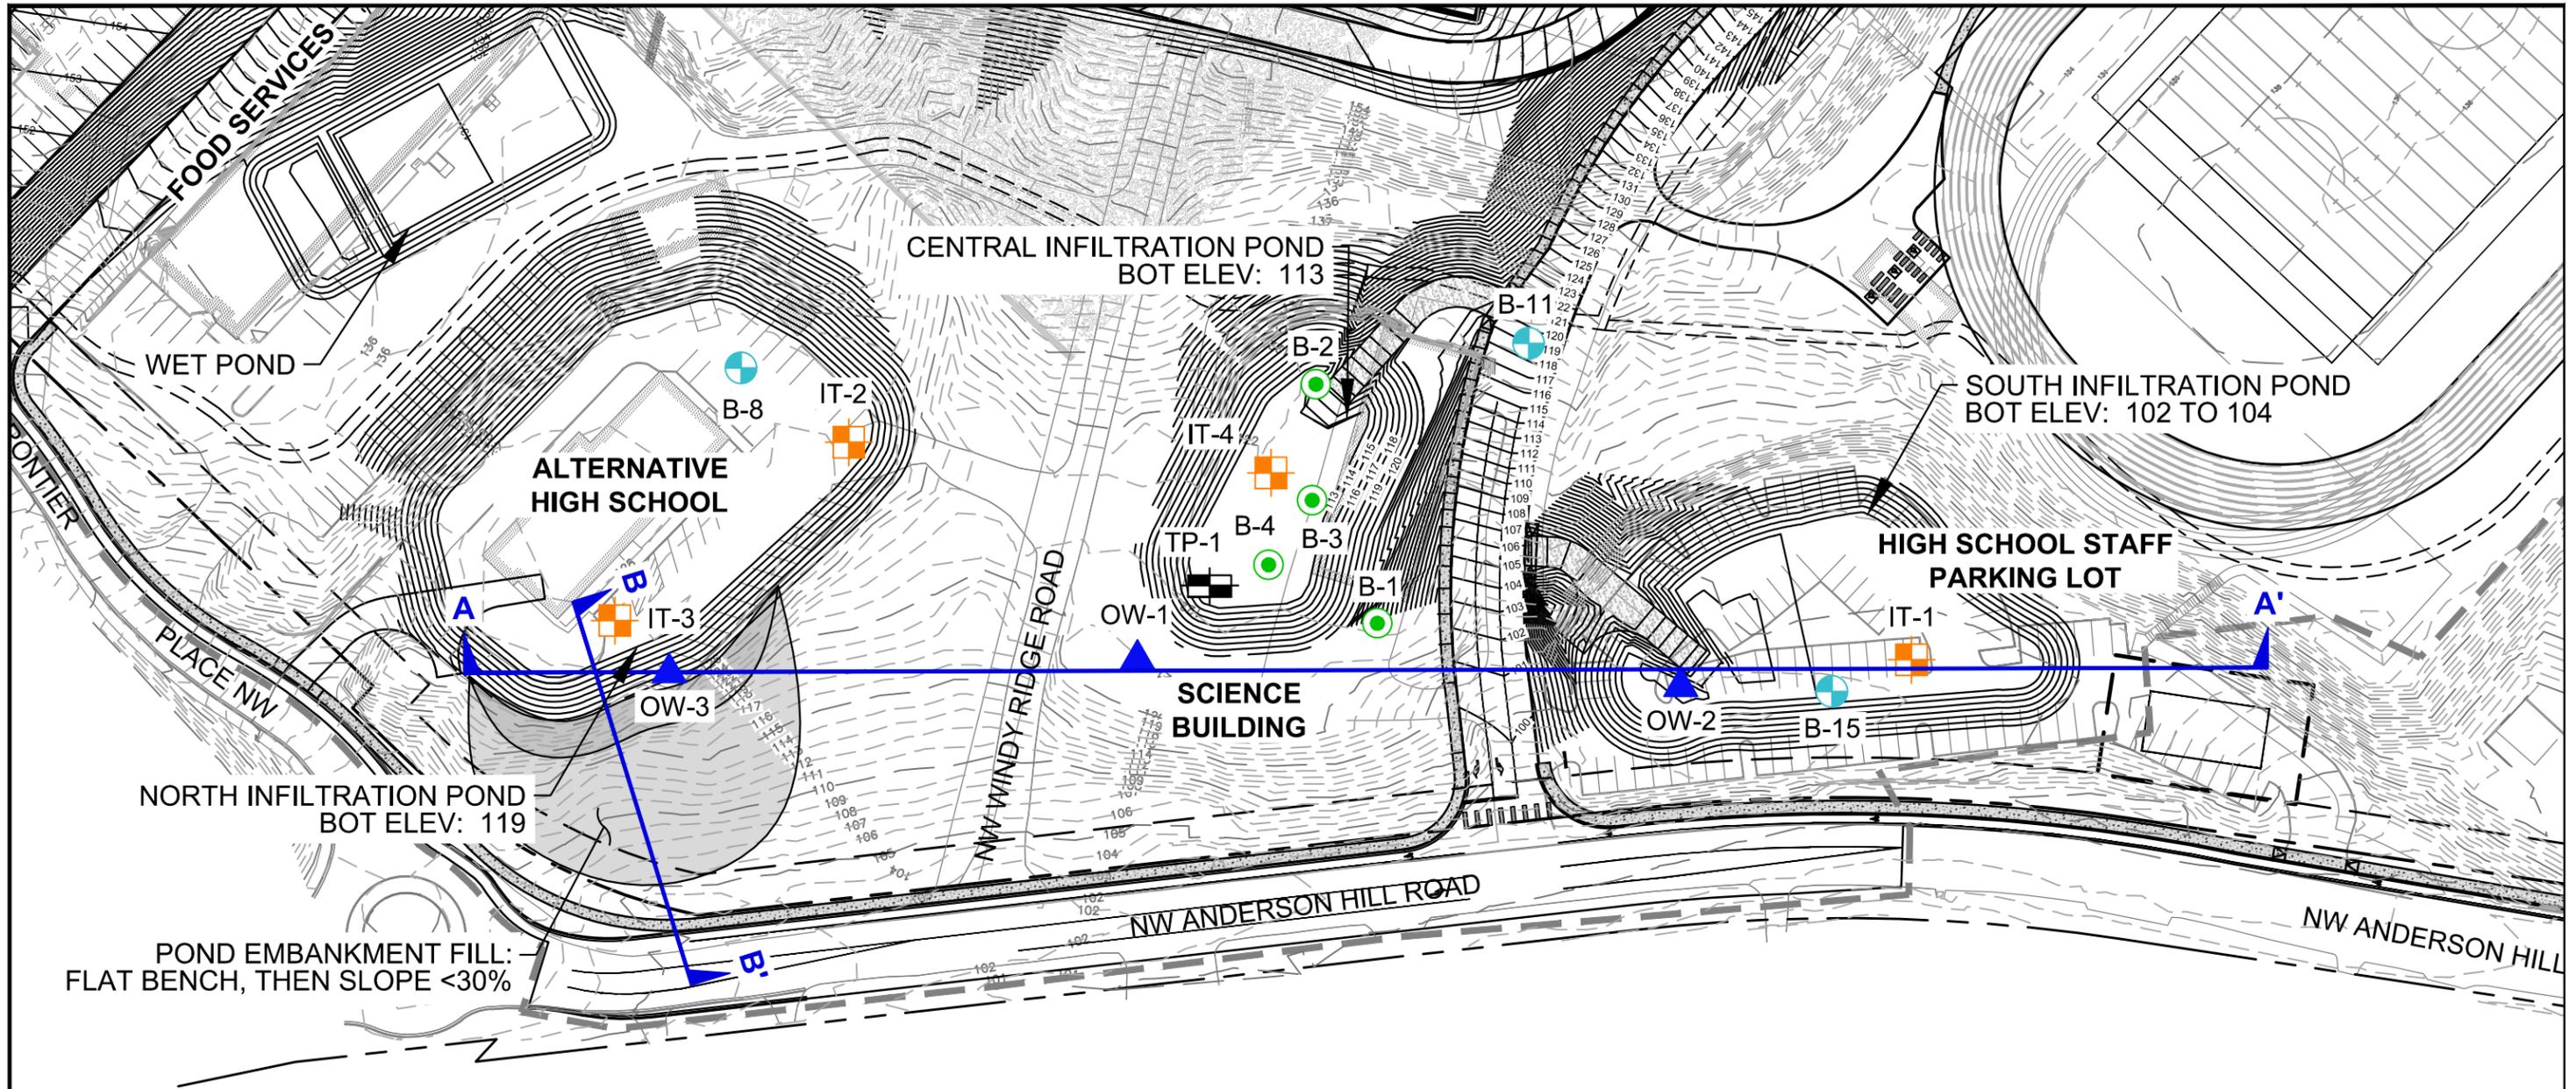
WE ESTIMATED THE RELATIVE LOCATION OF EACH EXPLORATION BY MEASURING FROM EXISTING FEATURES AND SCALING THESE MEASUREMENTS ONTO A LAYOUT PLAN SUPPLIED TO US. THE LOCATIONS DEPICTED ON THIS FIGURE SHOULD BE CONSIDERED ACCURATE ONLY TO THE DEGREE PERMITTED BY OUR DATA SOURCES AND IMPLIED BY OUR MEASURING METHODS.

The field work was performed on December 7, 2016, December 21 through 23, 2016, and February 20, 2017. Prior to, during, and after completing our field work, AHBL redesigned the infiltration facility multiple times. The exploration locations and testing were based on the infiltration pond locations, depths, and sizes provided by AHBL prior to our field work, and some of the locations were adjusted as the design progressed. The design infiltration facilities based on civil drawings received on March 2, 2017 are illustrated in the attached site and exploration plan (Figure 2).

In general, our explorations encountered fill over Glacial Till at the north and central ponds, and fill over Advance Outwash at the south pond. The approximate locations of our exploration borings, test pits, and infiltration pits are shown on Figure 2. This section summarizes the subsurface soil conditions encountered at each infiltration pond location.

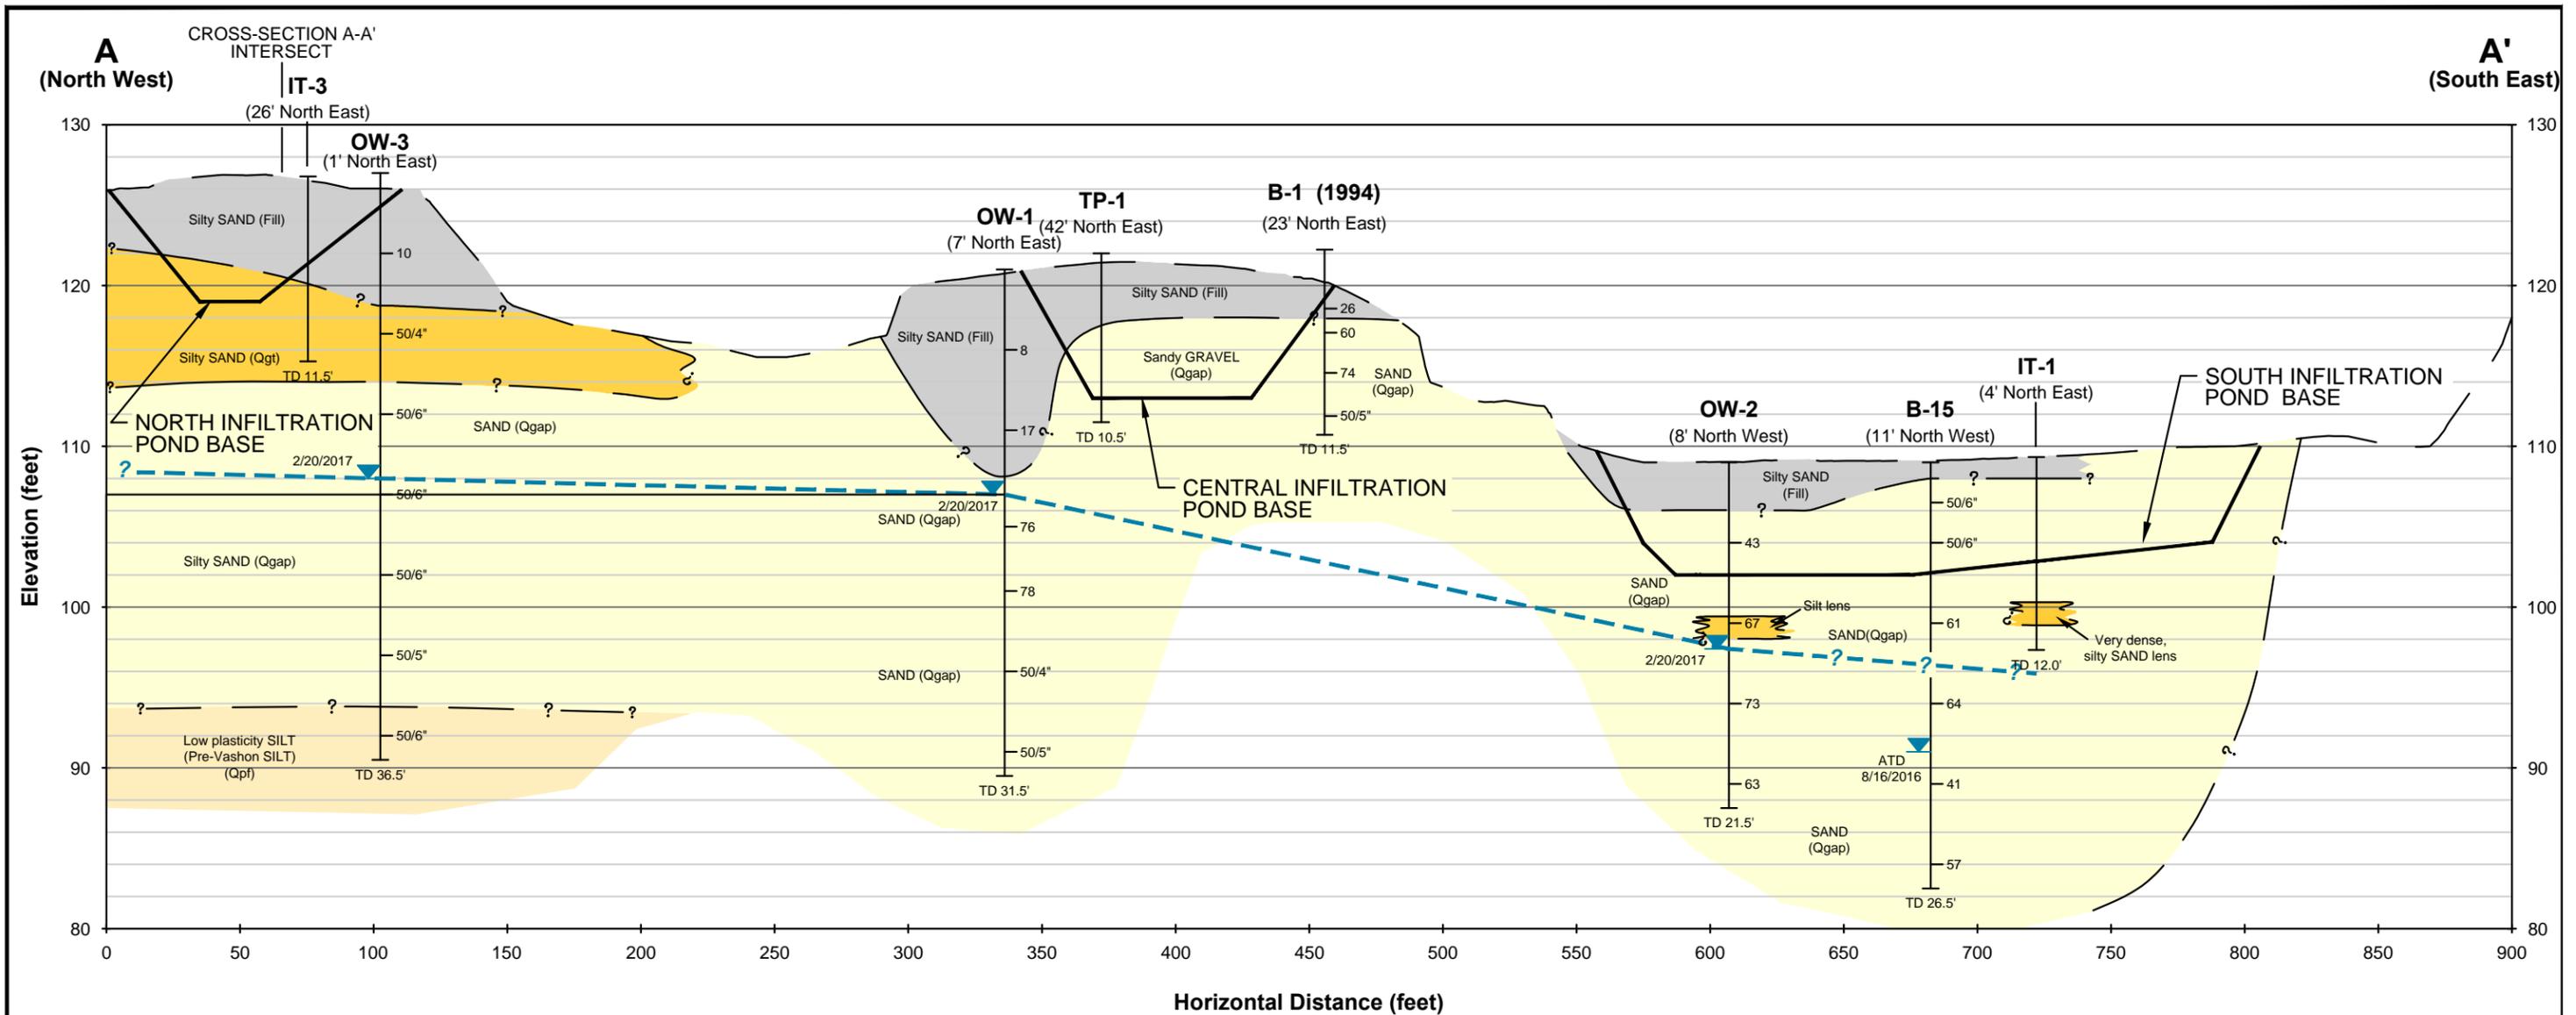
CENTRAL KITSAP HIGH SCHOOL AND MIDDLE SCHOOL CAMPUS	DATE MARCH 2017
		GEOLOGIC CROSS-SECTION A-A'	SCALE 1" = 60' PROJECT NO. 6-917-18096-0 FIGURE 3

- OW-3**
(1' North)
 - IT-3**
(26' North East)
 - OW-1**
(7' North East)
 - TP-1**
(42' North East)
 - B-1 (1994)**
(23' North East)
 - OW-2**
(8' North West)
 - B-15**
(11' North West)
 - IT-1**
(4' North East)
- STANDARD PENETRATION RESISTANCE IN BLOWS PER FOOT
- GROUNDWATER LEVEL - HIGHEST ELEVATION DURING WINTER SEASON OR AT TIME OF DRILLING
- TOTAL DEPTH OF BORING

Geotechnical laboratory test results indicate the Sandy Glacial Till has a fines content of 21 to 27 percent, and the Advance Outwash fines content varied between 1 and 18 percent. Table 1 summarizes the geotechnical testing results. Boring logs and test pit logs are included in Appendix A, and complete grain size distribution test results are presented in Appendix B. The boring logs and lab test results provide a detailed description of the soil strata. The soil stratigraphy adjacent to the three proposed infiltration pond locations is shown on cross-section A-A' (Figure 3).

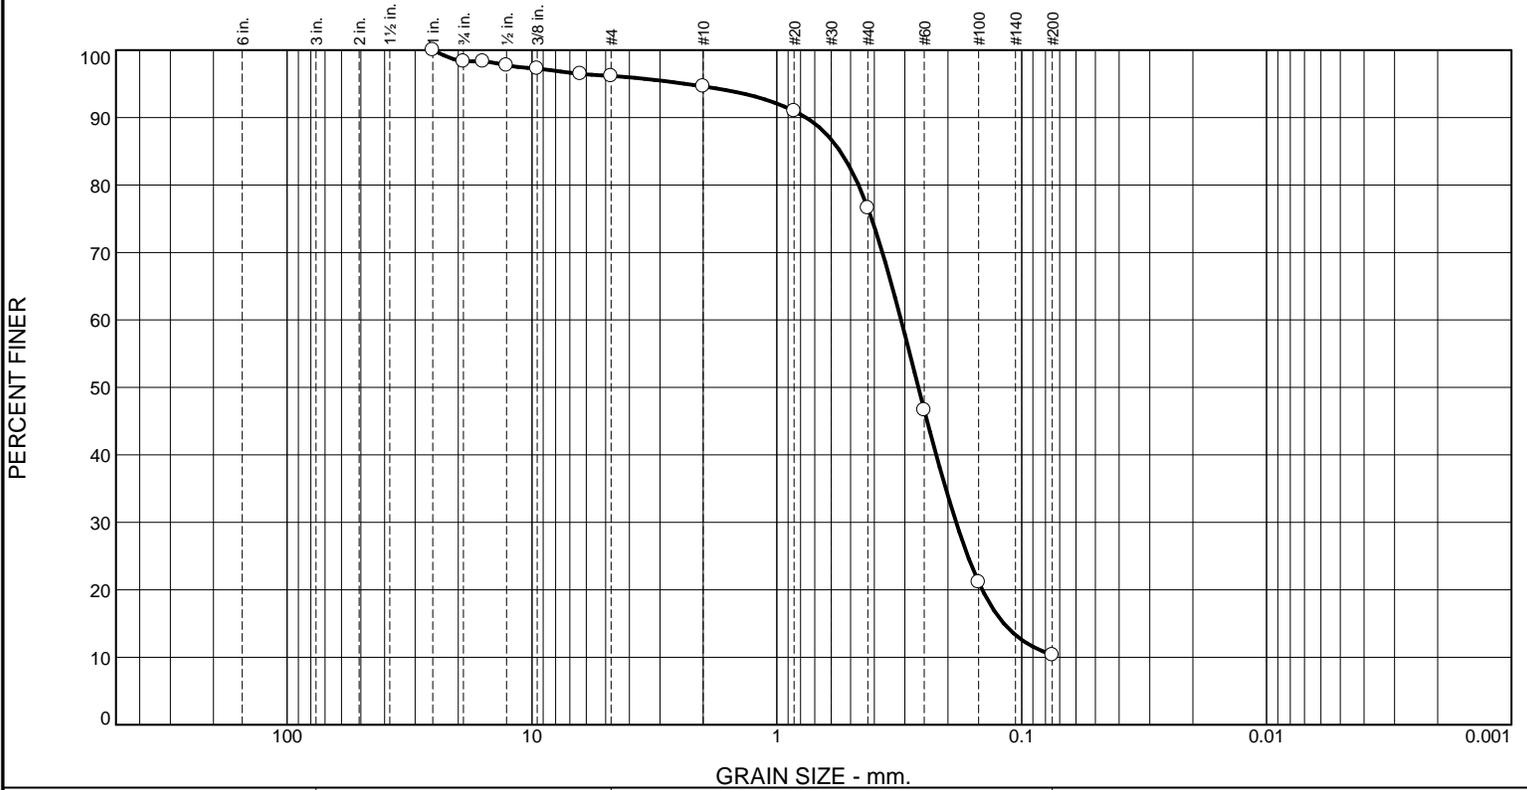
Particle Size Distribution Report

% +3"	% Gravel		% Sand			% Fines	
	Coarse	Fine	Coarse	Medium	Fine	Silt	Clay
0.0	1.7	2.1	1.6	18.0	66.3	10.3

SIEVE SIZE	PERCENT FINER	SPEC.* PERCENT	PASS? (X=NO)
1"	100.0		
3/4"	98.3		
5/8"	98.3		
1/2"	97.7		
3/8"	97.2		
1/4"	96.5		
#4	96.2		
#10	94.6		
#20	91.0		
#40	76.6		
#60	46.6		
#100	21.1		
#200	10.3

Poorly graded sand with silt
As Received Moisture: 8.3%

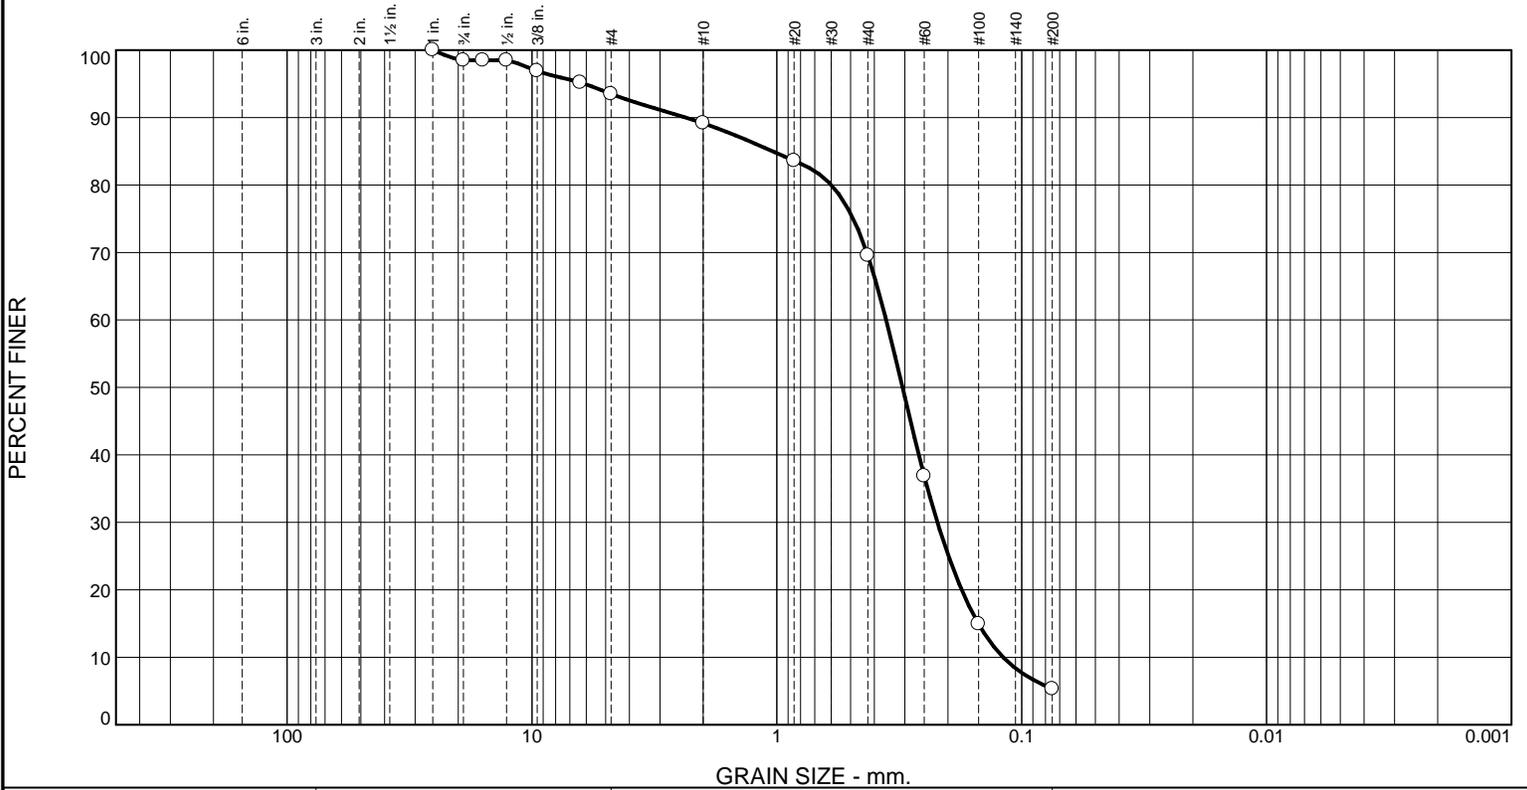
Particle Size Distribution Report

% +3"	% Gravel		% Sand			% Fines	
	Coarse	Fine	Coarse	Medium	Fine	Silt	Clay
0.0	1.5	5.0	4.3	19.6	64.3	5.3

SIEVE SIZE	PERCENT FINER	SPEC.* PERCENT	PASS? (X=NO)
1"	100.0		
3/4"	98.5		
5/8"	98.5		
1/2"	98.5		
3/8"	96.9		
1/4"	95.2		
#4	93.5		
#10	89.2		
#20	83.6		
#40	69.6		
#60	36.9		
#100	14.9		
#200	5.3

Poorly graded sand with silt
As Received Moisture: 14.6%

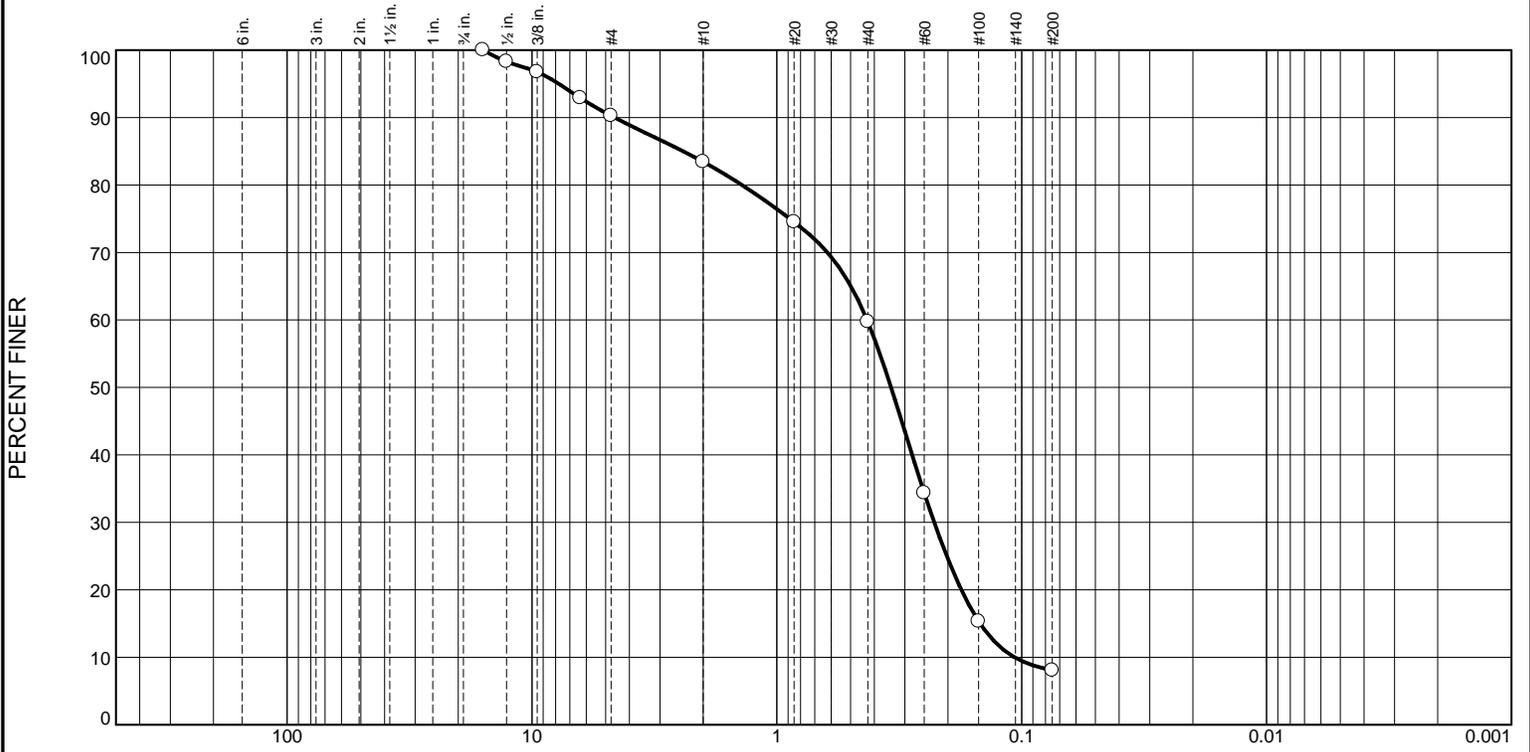
Particle Size Distribution Report

% +3"	% Gravel		% Sand			% Fines	
	Coarse	Fine	Coarse	Medium	Fine	Silt	Clay
0.0	0.0	9.7	6.9	23.7	51.6	8.1

SIEVE SIZE	PERCENT FINER	SPEC.* PERCENT	PASS? (X=NO)
5/8"	100.0		
1/2"	98.3		
3/8"	96.8		
1/4"	92.9		
#4	90.3		
#10	83.4		
#20	74.5		
#40	59.7		
#60	34.4		
#100	15.3		
#200	8.1

Poorly graded sand with silt
As Received Moisture: 12.5%

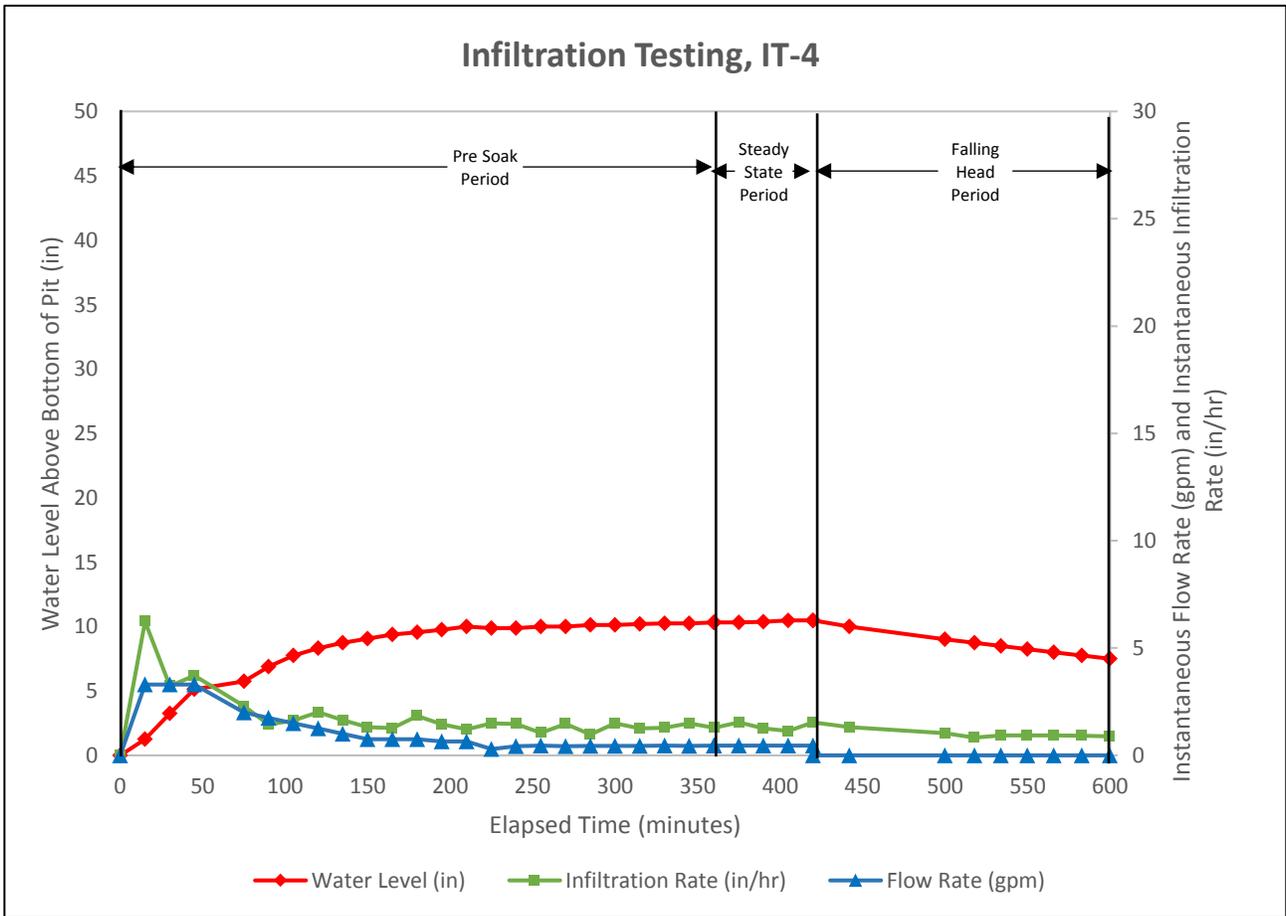
Job Name: Central Kitsap High School / Middle School
Job Number: 6-917-180960
Infiltration Test: IT-4 (Science Building - North Gravel Parking Area)
Date: 2/20/17

Time (hh:mm)	Elapsed Time (min)	Water Level Stage (in)	Flow Rate (gal/min)	Pit Volume (in ³)	Volume Added (Gal)	Infiltration Rate (in/hr)
Falling Head Period (3 hr)	4:10 PM	420	10.48	0	42669.3627	0.0	1.5
	4:32 PM	442	10	0	40715.0408	0.0	1.3
	5:30 PM	500	9	0	36643.5367	0.0	1.0
	5:48 PM	518	8.75	0	35625.6607	0.0	0.8
	6:04 PM	534	8.5	0	34607.7847	0.0	0.9
	6:20 PM	550	8.25	0	33589.9087	0.0	0.9
	6:36 PM	566	8	0	32572.0326	0.0	0.9
	6:53 PM	583	7.75	0	31554.1566	0.0	0.9
	7:10 PM	600	7.5	0	30536.2806	0.0	0.9
