Preliminary Drainage Report

Central Kitsap
High School and Middle School
3700 NW Anderson Hill Road
Silverdale, WA 98383
2160254.10

December 2016

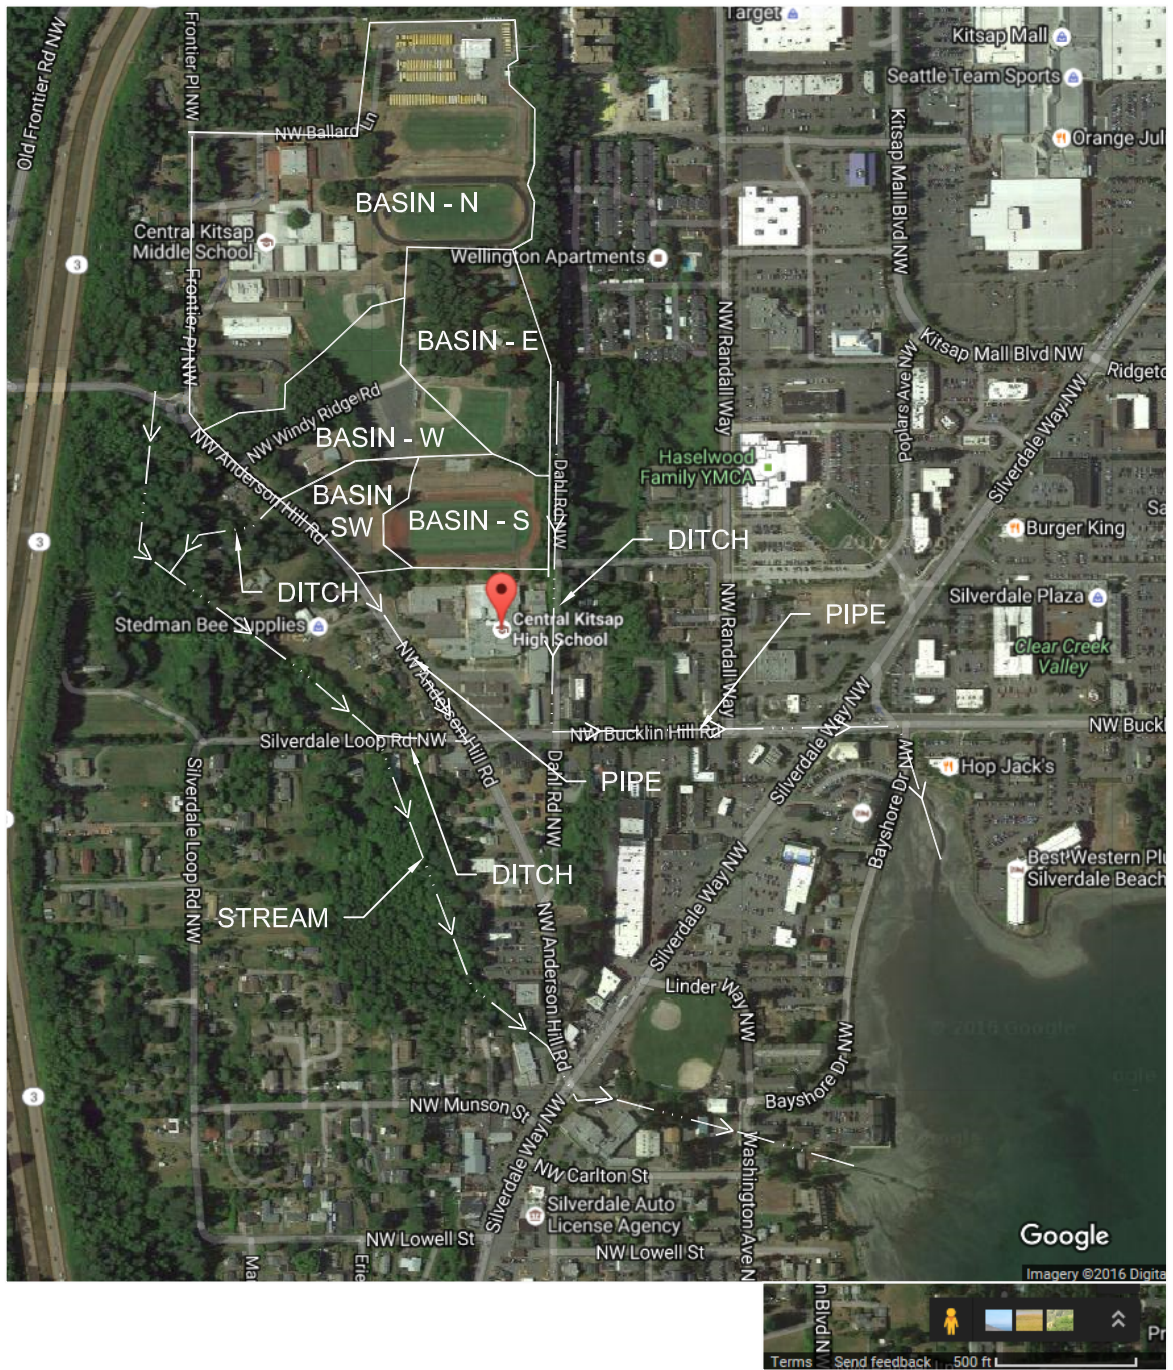
A-2

Each of the drainage basins, the associated discharge location, and the downstream drainage system are described below and illustrated on Appendix A-2, Downstream Basin Map and Appendix A-3, Existing Conditions Basin Map.

The drainage enters the pipe system on the north side of the road and drains the runoff about 800 feet to the east before turning south to an outlet into Dyes Inlet, located just to the east of Bayshore Drive NW. Along Bucklin Hill Road, the conveyance systems consist of 18-, 21-, and 24-inch concrete pipes. To assess the condition of the downstream storm system, County drawings were studied, drainage reports for downstream projects were reviewed, and County personnel were interviewed. From this investigation, it appears the downstream County system is adequately handling storm flows.

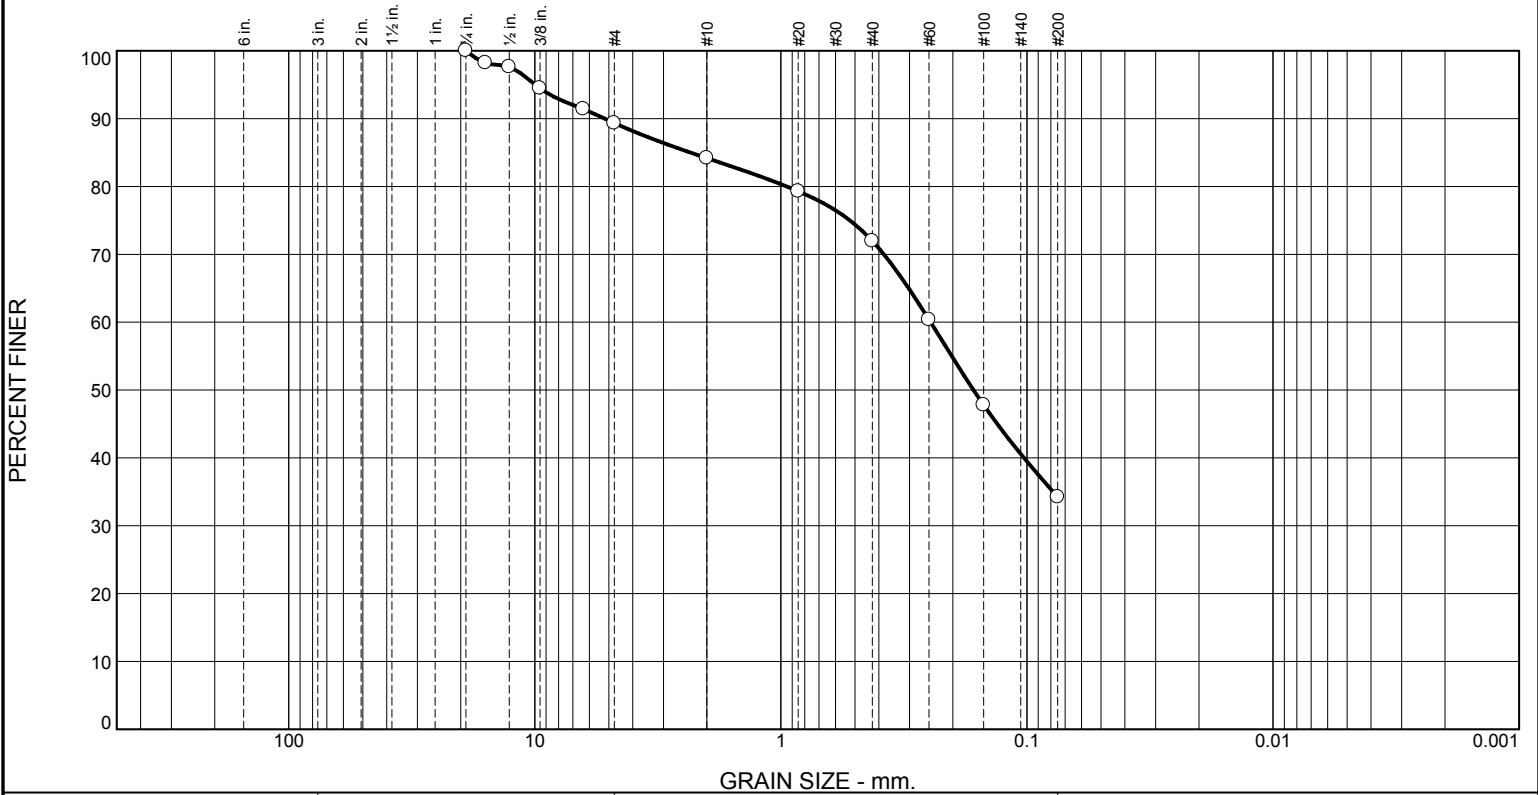
Particle Size Distribution Report

% +3"	% Gravel		% Sand			% Fines	
	Coarse	Fine	Coarse	Medium	Fine	Silt	Clay
0.0	0.0	10.7	5.1	12.2	37.8	34.2

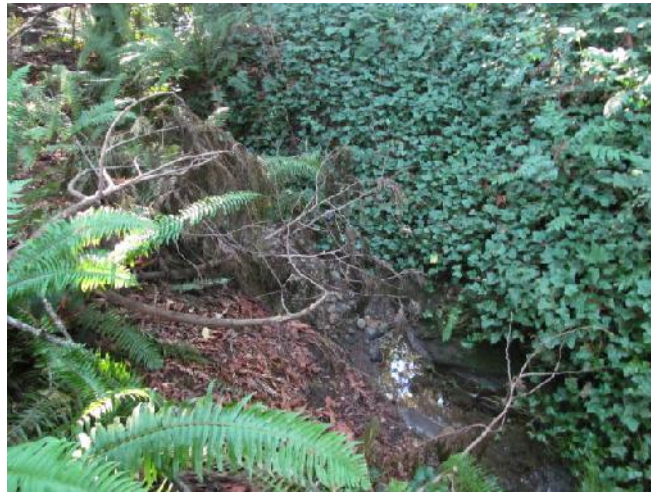
Photo 1 was taken of the short stream that begins just west of the CKSD administrative building along Frontier Place. This stream is confined to a steep sided, yet short ravine that ends a culvert under Anderson Hill Road.

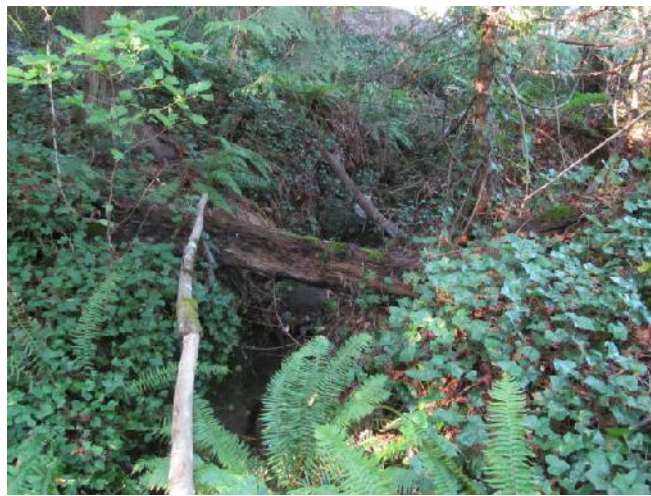
Photo 2 shows another view of the stream shown in Photo 1.

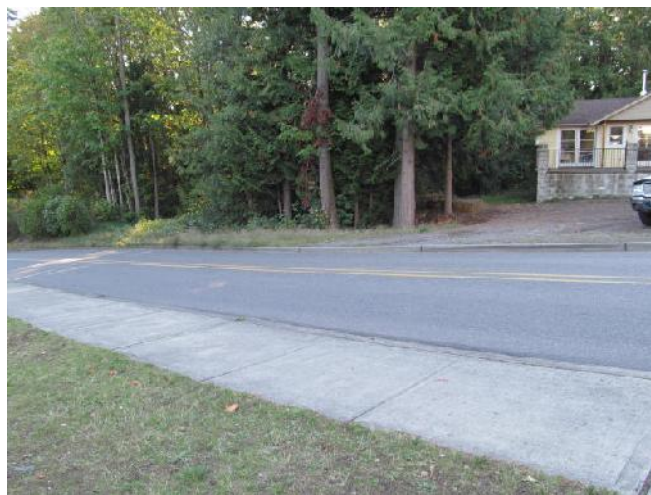
Photo 3 was taken from the CKSD property and looks southwesterly across Frontier Place toward the start of the short stream in Photos 1 and 2. The stream begins just downslope of the trees in the middle of the photo.

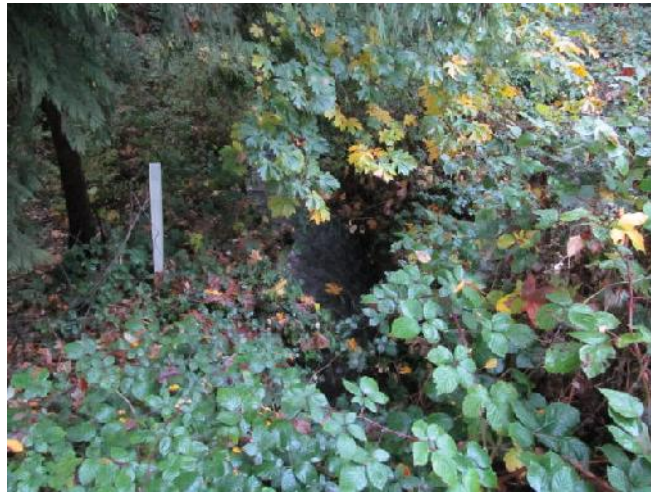
Photo 4 was taken from Anderson Hill Road and looks down into Koch Creek before it enters the culvert under the road. The slope down to the stream is dominated by blackberry thickets. There are upland areas on both sides of the creek. The small stream enters Koch Creek about 100 feet from this point.

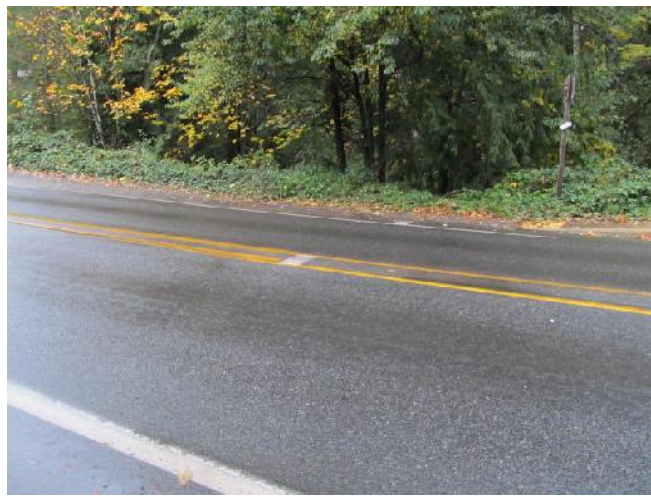
Photo 5 was taken from the south side of Anderson Hill Road and looks across the road at the culvert crossing.

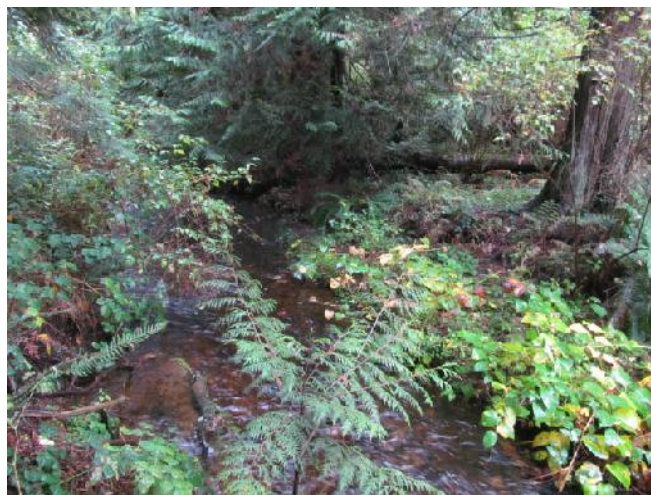
Photo 6 was taken from along Koch Creek downstream of Anderson Hill Road. There is level upland on both sides of the channel. Water flow in the channel was high and fast due to recent heavy rain events.

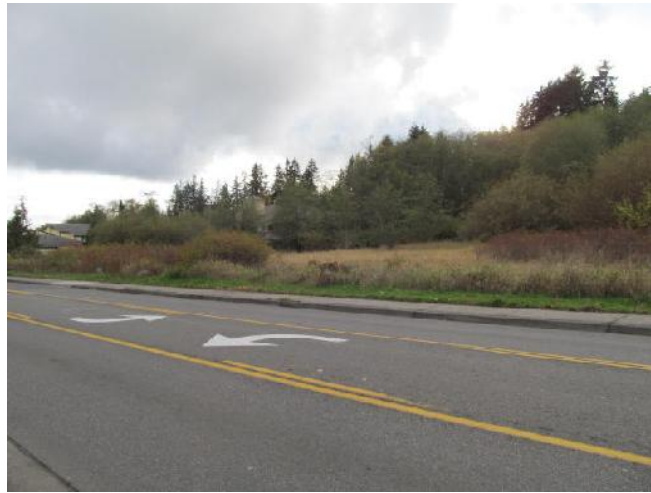
Photo 7 was taken from along Randall Way across from the wetland that lies north of the First American Building. The wetland occupies the level grassy area in the middle of the photo (just beyond the road) with a sloping portion in the deciduous trees just beyond the level portion. The tall conifer trees in the upper right background are just downslope and east of the CKSD property.

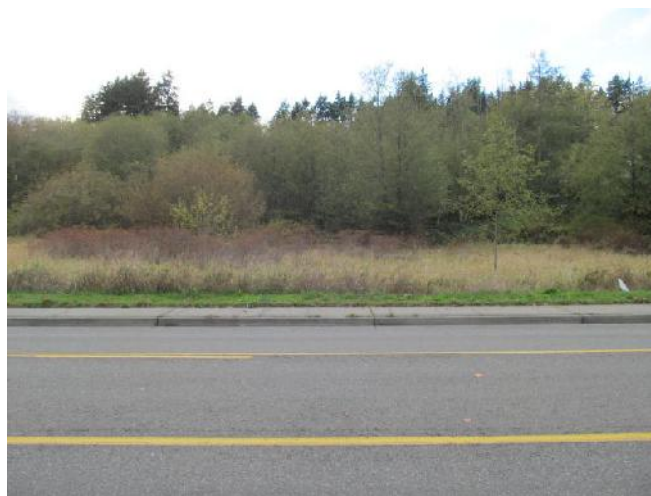
Photo 8 was taken from the same location as Photo 4 and looks west across Randall Way. As described in the Photo 4 discussion, the level grassy area is composed of depressional wetland with slope wetland conditions in the tree area. The conifer trees beyond the deciduous trees are growing on property adjacent to the CKSD property.

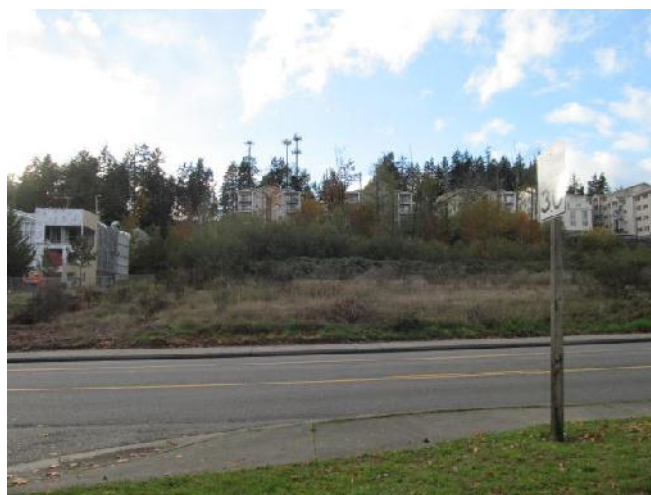
Photo 9 was taken from the southwest corner of the Target property, which is located across Randall Way from the Vintage at Silverdale Apartment complex. The apartments are located just this side of the cell towers and conifers trees in the background with the wetland just downslope of the apartments. The lower portion of this wetland was filled to accommodate future development.
